Access Compliance Report Public Rights-of-Way (Curb Ramps)

Intersection ID: N/A Main Street: FIRST RUN CT Cross Street: PAPER BIRCH DR SE Location: **Overall Compliance: No Severity Score:** 0 ADA ID: F0D7431D8F46 Ramp Type: Combination2Diag Initial Pass/Fail: Fail

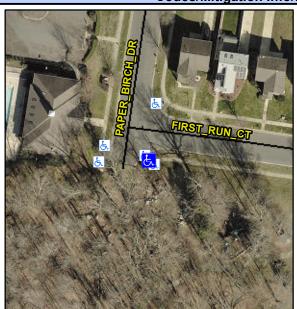
Street 1 Name StopSign Stop Condition-Street 1 **FIRST RUN CT** Street 2 Name None Stop Condition-Street 2 PAPER BIRCH DR

Compliance Description Possible Solutions: N/A Remove & Replace Curb Ramp With Two New Directional Ramps or No Equivalent. Yes No N/A No Surveyor Notes: N/A N/A N/A N/A N/A N/A PROW/ADA: N/A R304.5.1, R304.5.1, R304.5.3 N/A N/A N/A N/A N/A N/A
