# Access Compliance Report

## Public Rights-of-Way

Intersection ID: 48519	Main Street: GALLERIA BV	Cross Street: GALLERIA COURT DR	Location: NE
ADA ID: F0DA9B38B078	Ramp Type: PerpDiag	Initial Pass/Fail: Fail	Overall Compliance: No
Codes/Mitigation Info/Possible Solution		Field Measurements/Component Compliance	
Severity Score: 37.5

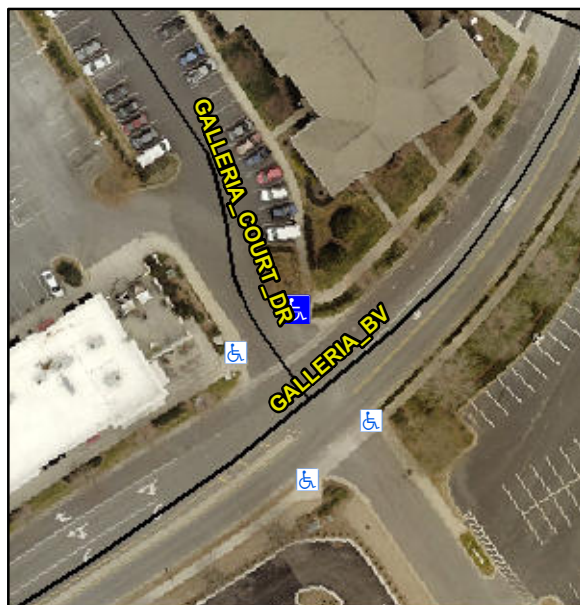
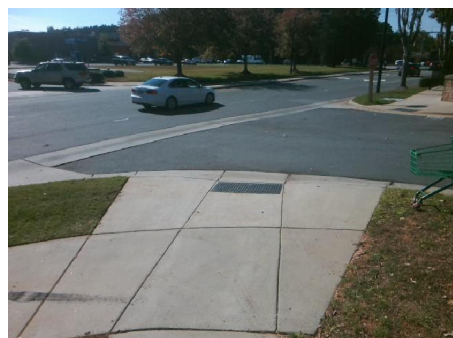
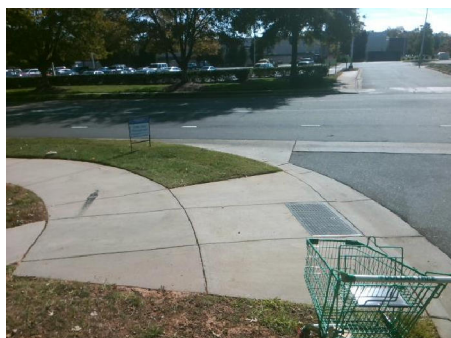
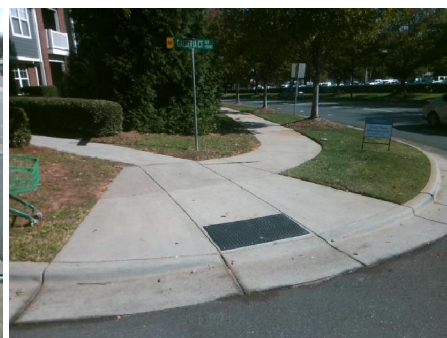
**Not Found, R304.2.2, R304.5.3**

Compliance	Description	Data	Compliance	Description	Data
N/A	Ramp Length (in)	85.0	No	Ramp Slope (%)	8.8
Yes	Ramp Width (in)	48.0	No	Ramp XSlope (%)	7.3
N/A	Flare Type LT	N/A	N/A	Flare Type RT	N/A
N/A	Flare Slope LT (%)	N/A	N/A	Flare Slope RT (%)	N/A
N/A	Flare Traversable LT?	N/A	N/A	Flare Traversable RT?	N/A
N/A	Landing Length (in)	N/A	N/A	DWS Provided?	N/A
N/A	Landing Width (in)	N/A	N/A	DWS Contrast?	N/A
N/A	Landing Slope (%)	N/A	N/A	DWS Length (in)	N/A
N/A	Landing X Slope (%)	N/A	N/A	DWS Full Width?	N/A
N/A	Landing Curb? (Y/N)	N/A	N/A	DWS Offset (in)	N/A
N/A	Shared Landing?	N/A			
N/A	Gutter Ponding?	N/A	N/A	Gutter Slope (%)	N/A
N/A	Gutter Lip Ht (in)	N/A	N/A	Gutter X Slope (%)	N/A
N/A	Painted X Walk1?	No	N/A	Painted X Walk2?	No
	X Walk 1 Direction	To SW		X Walk 2 Direction	To SE
N/A	X Walk 1 Width (in)	N/A	N/A	X Walk 2 Width (in)	N/A
	X Walk 1 Slope (%)	1.5		X Walk 2 Slope (%)	2.3
	X Walk 1 X Slope (%)	3.6		X Walk 2 X Slope (%)	1.7

N/A	Ramp inside XWalk1?	N/A	N/A	Ramp inside XWalk2?	N/A
	Road Slope (%)	4.0	N/A	Clear Space?	N/A
	Road X Slope (%)	0.2	N/A	Clear Space to XWalk (in)	N/A
N/A	Any Obstructions?	N/A	N/A	Storm Grate/Utility Hazard?	N/A
	Obstruction Type			Storm Grate/Utility Type	
		N/A			N/A
			Yes	Surface Condition? (G/P)	Good

**Remove & Replace Curb Ramp With Two New Directional Ramps or Equivalent.**

Total Cost: \$ 3200.00
