Access Compliance Report

Public Rights-of-Way

(Curb Ramps)

Intersection ID: 49274	Main Street: ROTHE_HOUSE_RD	Cross Street: REMINISCE_LN	Location: E
ADA ID: F0E2CDF14C04	Ramp Type: PerpDiag	Initial Pass/Fail: Fail	Overall Compliance: No
Severity Score: 13.75			
Codes/Mitigation Info/Possible Solution		Field Measurements/Component Compliance

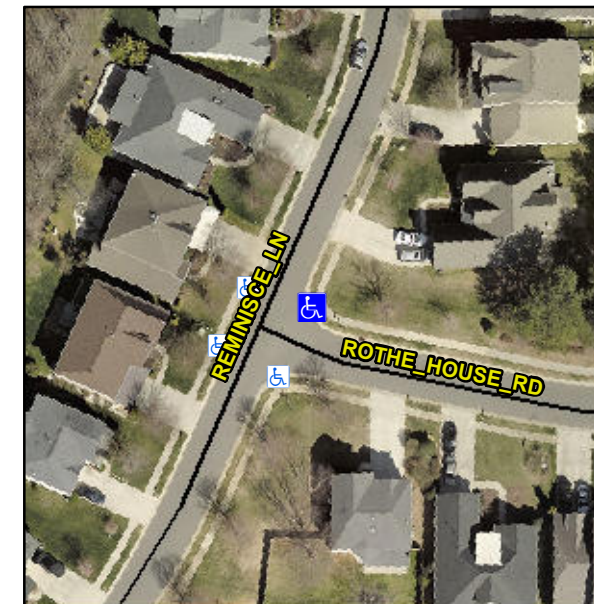
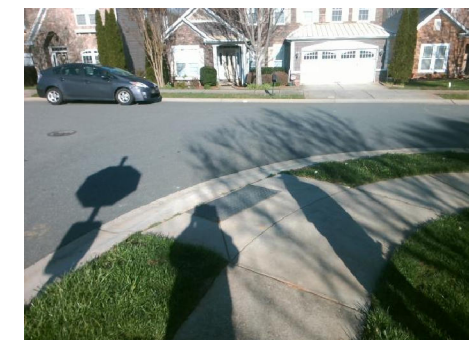
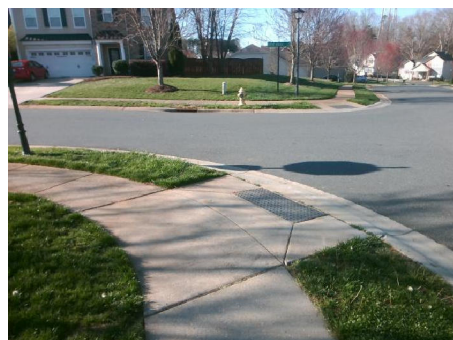
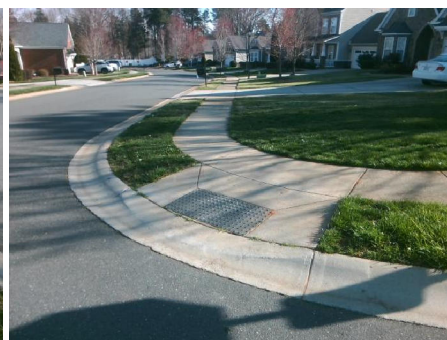
Not Found, R304.2.2, R304.5.3

Compliance	Description	Data	Compliance	Description	Data
N/A	Ramp Length (in)	47.5	No	Ramp Slope (%)	10.9
Yes	Ramp Width (in)	48.0	No	Ramp XSlope (%)	2.7
N/A	Flare Type LT	N/A	N/A	Flare Type RT	N/A
N/A	Flare Slope LT (%)	N/A	N/A	Flare Slope RT (%)	N/A
N/A	Flare Traversable LT?	N/A	N/A	Flare Traversable RT?	N/A
N/A	Landing Length (in)	N/A	N/A	DWS Provided?	N/A
N/A	Landing Width (in)	N/A	N/A	DWS Contrast?	N/A
N/A	Landing Slope (%)	N/A	N/A	DWS Length (in)	N/A
N/A	Landing X Slope (%)	N/A	N/A	DWS Full Width?	N/A
N/A	Landing Curb? (Y/N)	N/A	N/A	DWS Offset (in)	N/A
N/A	Shared Landing?	N/A			
N/A	Gutter Ponding?	N/A	N/A	Gutter Slope (%)	N/A
N/A	Gutter Lip Ht (in)	N/A	N/A	Gutter X Slope (%)	N/A
N/A	Painted X Walk1?	No	N/A	Painted X Walk2?	No
	X Walk 1 Direction	To NW		X Walk 2 Direction	To SW
N/A	X Walk 1 Width (in)	N/A	N/A	X Walk 2 Width (in)	N/A
	X Walk 1 Slope (%)	1.1		X Walk 2 Slope (%)	2.5
	X Walk 1 X Slope (%)	3.1		X Walk 2 X Slope (%)	2.4

N/A	Ramp inside XWalk1?	N/A	N/A	Ramp inside XWalk2?	N/A
	Road Slope (%)	1.6	N/A	Clear Space?	N/A
	Road X Slope (%)	1.5	N/A	Clear Space to XWalk (in)	N/A
N/A	Any Obstructions?	N/A	N/A	Storm Grate/Utility Hazard?	N/A
	Obstruction Type			Storm Grate/Utility Type	
		N/A			N/A
			Yes	Surface Condition? (G/P)	Good

Possible Solutions:

Remove & Replace Curb Ramp With Two New Directional Ramps or Equivalent.
