## Access Compliance Report Public Rights-of-Way (Curb Ramps)

Intersection ID: 42457 Main Street: SUNNINGHILL\_PARK\_RD Cross Street: HONOR\_GUARD\_AV Location: NE

ADA ID: F0F78024BC78 Ramp Type: PerpDiag Initial Pass/Fail: Fail Overall Compliance: No Severity Score: 42.5

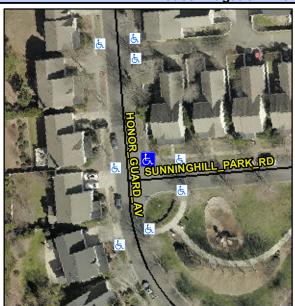
Not Found, R304.5.1, R304.2.2, R304.5.3

Compliance Description Data Compliance Description Data No N/A Ramp Length (in) 76.0 Ramp Slope (%) 9.1 No Ramp XSlope (%) No Ramp Width (in) 33.0 6.1 N/A N/A Flare Type LT N/A Flare Type RT N/A N/A N/A N/A Flare Slope RT (%) N/A Flare Slope LT (%) N/A Flare Traversable LT? N/A N/A Flare Traversable RT? N/A N/A N/A N/A **DWS Provided?** N/A Landing Length (in) N/A Landing Width (in) N/A N/A **DWS Contrast?** N/A N/A N/A N/A Landing Slope (%) DWS Length (in) N/A N/A Landing X Slope (%) N/A N/A DWS Full Width? N/A N/A Landing Curb? (Y/N) N/A N/A DWS Offset (in) N/A N/A N/A Shared Landing? N/A **Gutter Ponding?** N/A N/A Gutter Slope (%) N/A N/A Gutter Lip Ht (in) N/A N/A Gutter X Slope (%) N/A N/A Painted X Walk1? No N/A Painted X Walk2? No X Walk 1 Direction To W X Walk 2 Direction To S N/A N/A X Walk 1 Width (in) X Walk 2 Width (in) N/A X Walk 1 Slope (%) X Walk 2 Slope (%) 2.4 2.6 X Walk 1 X Slope (%) 2.6 X Walk 2 X Slope (%) 0.1 N/A N/A N/A Ramp inside XWalk2? N/A Ramp inside XWalk1? Road Slope (%) 2.6 N/A Clear Space? N/A N/A Road X Slope (%) 1.0 Clear Space to XWalk (in) N/A N/A N/A N/A Any Obstructions? Storm Grate/Utility Hazard? N/A **Obstruction Type** Storm Grate/Utility Type N/A N/A Yes Surface Condition? (G/P) Good

Remove & Replace Curb Ramp With Two New Directional Ramps or Equivalent.
