# Access Compliance Report

## Public Rights-of-Way

### (Curb Ramps)

Intersection ID: 30109	Main Street: HARLAND_ST	Cross Street: WANDERING_CREEK_DR	Location: S
ADA ID: F112D50D9EC2	Ramp Type: PerpDiag	Initial Pass/Fail: Fail	Overall Compliance: No
Codes/Mitigation Info/Possible Solution		Field Measurements/Component Compliance	
Severity Score: 10

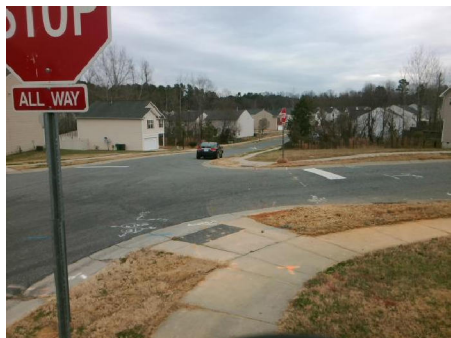
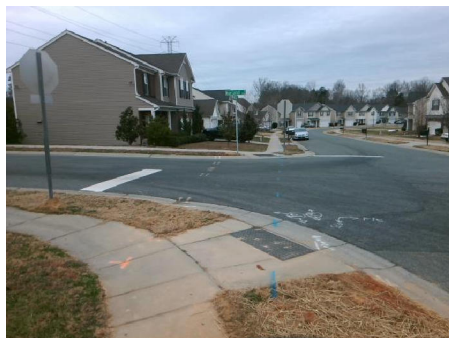
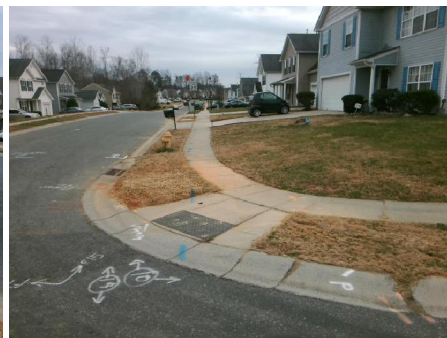
**Not Found, R304.5.1, R304.5.3**

Compliance	Description	Data	Compliance	Description	Data
N/A	Ramp Length (in)	60.0	Yes	Ramp Slope (%)	5.5
No	Ramp Width (in)	39.0	No	Ramp XSlope (%)	2.2
N/A	Flare Type LT	N/A	N/A	Flare Type RT	N/A
N/A	Flare Slope LT (%)	N/A	N/A	Flare Slope RT (%)	N/A
N/A	Flare Traversable LT?	N/A	N/A	Flare Traversable RT?	N/A
N/A	Landing Length (in)	N/A	N/A	DWS Provided?	N/A
N/A	Landing Width (in)	N/A	N/A	DWS Contrast?	N/A
N/A	Landing Slope (%)	N/A	N/A	DWS Length (in)	N/A
N/A	Landing X Slope (%)	N/A	N/A	DWS Full Width?	N/A
N/A	Landing Curb? (Y/N)	N/A	N/A	DWS Offset (in)	N/A
N/A	Shared Landing?	N/A			
N/A	Gutter Ponding?	N/A	N/A	Gutter Slope (%)	N/A
N/A	Gutter Lip Ht (in)	N/A	N/A	Gutter X Slope (%)	N/A
N/A	Painted X Walk1?	No	N/A	Painted X Walk2?	No
	X Walk 1 Direction	To NE		X Walk 2 Direction	To NW
N/A	X Walk 1 Width (in)	N/A	N/A	X Walk 2 Width (in)	N/A
	X Walk 1 Slope (%)	2.2		X Walk 2 Slope (%)	1.0
	X Walk 1 X Slope (%)	0.1		X Walk 2 X Slope (%)	4.2

N/A	Ramp inside XWalk1?	N/A	N/A	Ramp inside XWalk2?	N/A
	Road Slope (%)	3.5	N/A	Clear Space?	N/A
	Road X Slope (%)	4.3	N/A	Clear Space to XWalk (in)	N/A
N/A	Any Obstructions?	N/A	N/A	Storm Grate/Utility Hazard?	N/A
	Obstruction Type			Storm Grate/Utility Type	
		N/A			N/A
			Yes	Surface Condition? (G/P)	Good

**Remove & Replace Curb Ramp With Two New Directional Ramps or Equivalent.**
