# Access Compliance Report

## Public Rights-of-Way

### (Curb Ramps)

| Intersection ID: 44317 | Main Street: E_9TH_ST | Cross Street: N_CALDWELL_ST | Location: NW |

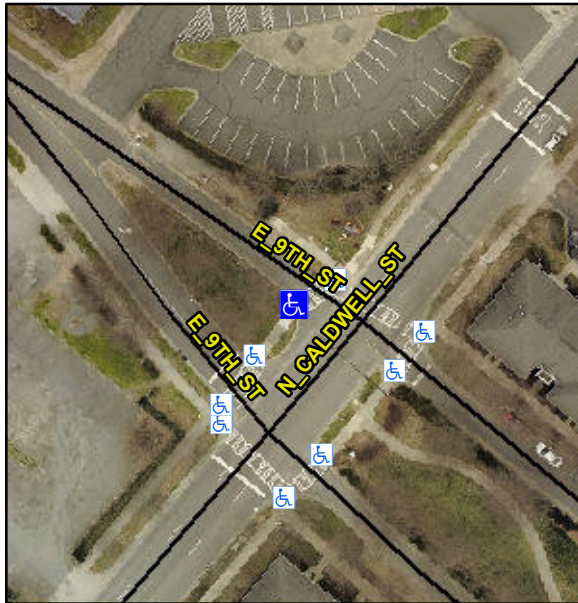
| ADA ID: F114E2FAC58F | Ramp Type: Perp | Initial Pass/Fail: Fail | Overall Compliance: No |

**Not Found, R304.5.1, R304.2.2, R304.5.3**

**Remove & Replace Entire Ramp.**

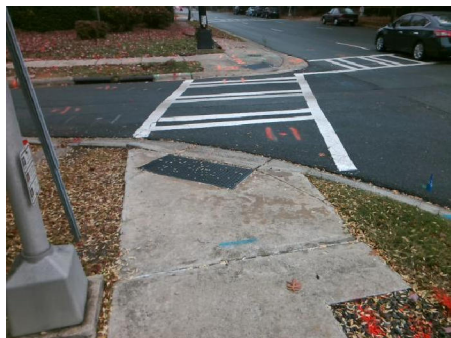
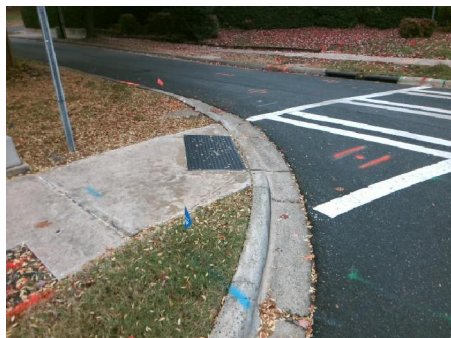
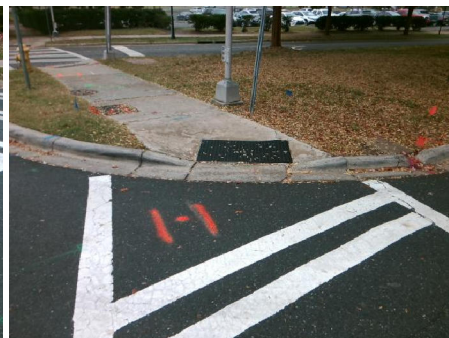
| Compliance | Description | Data | Compliance | Description | Data |
|---|---|---|---|---|---|
| N/A | Ramp Length (in) | 42.0 | No | Ramp Slope (%) | 8.4 |
| No | Ramp Width (in) | 44.0 | No | Ramp XSlope (%) | 3.7 |
