Intersection ID: 13961	Main Street: E_KINGSTON_AV	Cross Street: SOUTH_BV	Location:	E
ADA ID: F12F4ACA0226	Ramp Type: PerpDiag	Initial Pass/Fail: Fail	Overall Compliance: No	Severity Score: 13.75

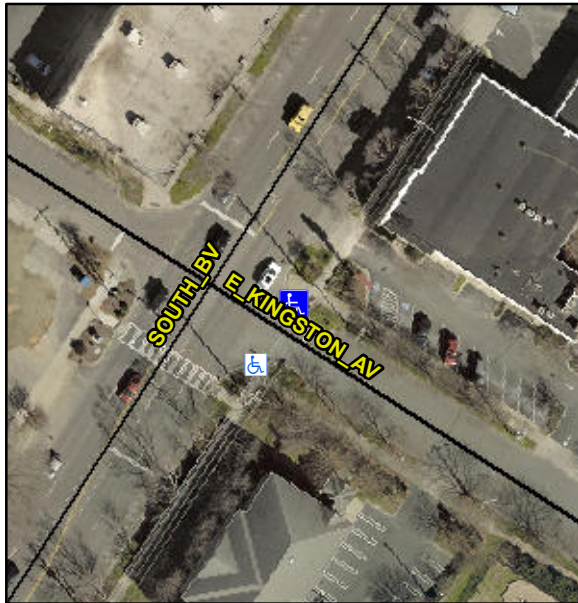
**Not Found, R304.2.2, R304.5.3**

Compliance	Description	Data	Compliance	Description	Data
N/A	Ramp Length (in)	28.0	No	Ramp Slope (%)	8.4
Yes	Ramp Width (in)	58.5	No	Ramp XSlope (%)	2.8
N/A	Flare Type LT	N/A	N/A	Flare Type RT	N/A
N/A	Flare Slope LT (%)	N/A	N/A	Flare Slope RT (%)	N/A
N/A	Flare Traversable LT?	N/A	N/A	Flare Traversable RT?	N/A
N/A	Landing Length (in)	N/A	N/A	DWS Provided?	N/A
N/A	Landing Width (in)	N/A	N/A	DWS Contrast?	N/A
N/A	Landing Slope (%)	N/A	N/A	DWS Length (in)	N/A
N/A	Landing X Slope (%)	N/A	N/A	DWS Full Width?	N/A
N/A	Landing Curb? (Y/N)	N/A	N/A	DWS Offset (in)	N/A
N/A	Shared Landing?	N/A			
N/A	Gutter Ponding?	N/A	N/A	Gutter Slope (%)	N/A
N/A	Gutter Lip Ht (in)	N/A	N/A	Gutter X Slope (%)	N/A
N/A	Painted X Walk1?	No	N/A	Painted X Walk2?	No
	X Walk 1 Direction	To NW		X Walk 2 Direction	To SW
N/A	X Walk 1 Width (in)	N/A	N/A	X Walk 2 Width (in)	N/A
	X Walk 1 Slope (%)	0.0		X Walk 2 Slope (%)	1.5
	X Walk 1 X Slope (%)	3.1		X Walk 2 X Slope (%)	0.4

N/A	Ramp inside XWalk1?	N/A	N/A	Ramp inside XWalk2?	N/A
	Road Slope (%)	1.3	N/A	Clear Space?	N/A
	Road X Slope (%)	1.5	N/A	Clear Space to XWalk (in)	N/A
N/A	Any Obstructions?	N/A	N/A	Storm Grate/Utility Hazard?	N/A
	Obstruction Type			Storm Grate/Utility Type	
		N/A			N/A
			Yes	Surface Condition? (G/P)	Good

**Remove & Replace Curb Ramp With Two New Directional Ramps or Equivalent.**
