Access Compliance Report Public Rights-of-Way (Curb Ramps)

Intersection ID: 8876 Main Street: ENNIS_AV Cross Street: N_GRAHAM_ST Location: SE

ADA ID: F1360BDF4F37 Ramp Type: Perp Initial Pass/Fail: Fail Overall Compliance: No Severity Score: 33.75

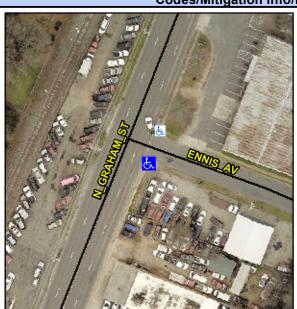
Field Measurements/Component Compliance								
Compl	iance Description	Data	Compl	liance	Description	Data		
N/A	Ramp Length (in)	62.0	No	Ramp	Slope (%)	12.7		
No	Ramp Width (in)	36.0	Yes	Ramp	XSlope (%)	1.7		
N/A	Flare Type LT	N/A	N/A	Flare	Type RT	N/A		
N/A	Flare Slope LT (%)	N/A	N/A	Flare	Slope RT (%)	N/A		
N/A	Flare Traversable LT?	N/A	N/A	Flare	Traversable RT?	N/A		
N/A	Landing Length (in)	N/A	N/A	DWS	Provided?	N/A		
N/A	Landing Width (in)	N/A	N/A	DWS	Contrast?	N/A		
N/A	Landing Slope (%)	N/A	N/A	DWS	Length (in)	N/A		
N/A	Landing X Slope (%)	N/A	N/A	DWS	Full Width?	N/A		
N/A	Landing Curb? (Y/N)	N/A	N/A	DWS	Offset (in)	N/A		
N/A	Shared Landing?	N/A						
N/A	Gutter Ponding?	N/A	N/A	Gutte	r Slope (%)	N/A		
N/A	Gutter Lip Ht (in)	0.5	N/A	Gutte	r X Slope (%)	N/A		
N/A	Painted X Walk1?	No	N/A	Paint	ed X Walk2?	N/A		
	X Walk 1 Direction	To NE		X Wa	lk 2 Direction	N/A		
N/A	X Walk 1 Width (in)	N/A	N/A	X Wa	lk 2 Width (in)	N/A

X Walk 1 Slope (%)	4.0		X Wa	lk 2 Slope (%)	N/A		
	X Walk 1 X Slope (%)	3.7		X Wa	lk 2 X Slope (%)	N/A		
N/A	Ramp inside XWalk1?	N/A	N/A	Ramp	inside XWalk2?	N/A		
	Road Slope (%)	N/A	N/A	Clear	Space?	N/A		
	Road X Slope (%)	N/A	N/A	Clear	Space to XWalk (in)	N/A		
N/A	Any Obstructions?	N/A	N/A	Storm	n Grate/Utility Hazard?	N/A		
	Obstruction Type			Storm	n Grate/Utility Type			
		N/A				N/A		
			Yes	Surfa	ce Condition? (G/P)	Good

Possible Solution				
Possible Solutions:	<u>c</u>			
Remove & Replace Entire Ramp.				
·	N			
	N			
	N			
	N			
	N			
Surveyor Notes:	N			
N/A	N			
	N			
	N			
	N			
PROW/ADA:	N			
R304.5.1, R304.2.2	N			
	N			
	N			
	N
