# Access Compliance Report

## Public Rights-of-Way

| Intersection ID: 16107 | Main Street: QUEENS_RD_WEST | Cross Street: RADCLIFFE_AV | Location: SE |
| ADA ID: F13C4AD3D35A | Ramp Type: PerpDiag | Initial Pass/Fail: Fail | Overall Compliance: No |

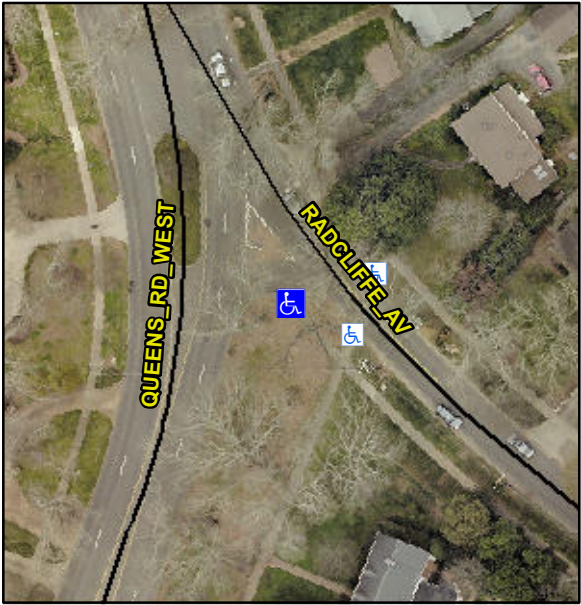
| Severity Score: 33.75 | | | |

| <p>Surveyor Notes:</p> <p>N/A</p> <p>PROW/ADA:</p> <p>R304.5.1, R304.5.3</p> | | | No | | Ramp Width (in) | | 43.0 | No | Ramp XSlope (%) | 7.4 |

| | Remove & Replace Curb Ramp With Two New Directional Ramps or Equivalent. | | N/A | | Ramp Length (in) | | 89.0 | Yes | Ramp Slope (%) | 5.8 |
