## **Access Compliance Report Public Rights-of-Way** (Curb Ramps)

Intersection ID: 30513 Main Street: S\_TRYON\_ST Cross Street: YORK\_CENTER\_DR Location: NE ADA ID: F142142EE3C3 Ramp Type: PerpDiag Initial Pass/Fail: Fail **Overall Compliance: No** Severity Score: 46.25

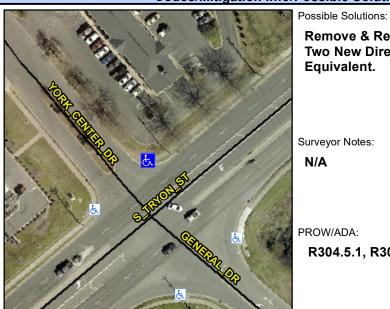
R304.5.1, R304.2.2, R304.5.3

Field Measurements/Component Compliance						
Comp	liance Description	Data	Comp	liance Description	Data	
N/A	Ramp Length (in)	48.0	No	Ramp Slope (%)	10.7	
No	Ramp Width (in)	45.0	No	Ramp XSlope (%)	7.2	
N/A	Flare Type LT	N/A	N/A	Flare Type RT	N/A	
N/A	Flare Slope LT (%)	N/A	N/A	Flare Slope RT (%)	N/A	
N/A	Flare Traversable LT?	N/A	N/A	Flare Traversable RT?	N/A	
N/A	Landing Length (in)	N/A	N/A	DWS Provided?	N/A	
N/A	Landing Width (in)	N/A	N/A	DWS Contrast?	N/A	
N/A	Landing Slope (%)	N/A	N/A	DWS Length (in)	N/A	
N/A	Landing X Slope (%)	N/A	N/A	DWS Full Width?	N/A	
N/A	Landing Curb? (Y/N)	N/A	N/A	DWS Offset (in)	N/A	
N/A	Shared Landing?	N/A				
N/A	Gutter Ponding?	N/A	N/A	Gutter Slope (%)	N/A	
N/A	Gutter Lip Ht (in)	N/A	N/A	Gutter X Slope (%)	N/A	
N/A	Painted X Walk1?	No	N/A	Painted X Walk2?	No	
	X Walk 1 Direction	To SW		X Walk 2 Direction	To SE	
N/A	X Walk 1 Width (in)	N/A	N/A	X Walk 2 Width (in)	N/A	
	X Walk 1 Slope (%)	0.9		X Walk 2 Slope (%)	3.0

X Walk 1 X Slope (%)	3.0		X Walk 2 X Slope (%)	1.8	
N/A	Ramp inside XWalk1?	N/A	N/A	Ramp inside XWalk2?	N/A	
	Road Slope (%)	3.4	N/A	Clear Space?	N/A	
	Road X Slope (%)	1.6	N/A	Clear Space to XWalk (in)	N/A	
N/A	Any Obstructions?	N/A	N/A	Storm Grate/Utility Hazard?	N/A	
	Obstruction Type			Storm Grate/Utility Type		
		N/A			N/A	
			Yes	Surface Condition? (G/P)	Good

Remove & Replace Curb Ramp With **Two New Directional Ramps or** Equivalent.

3200.00
