Access Compliance Report

Public Rights-of-Way

(Curb Ramps)

| Intersection ID: 46393 | Main Street: MALLARD_CREEK_RD | Cross Street: MALLARD_HILL_DR | Location: W |

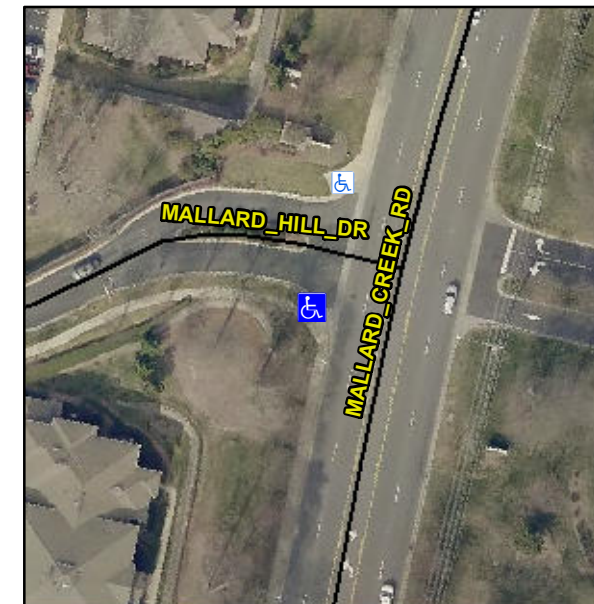
| ADA ID: F1469BEFDDC4 | Ramp Type: Perp | Initial Pass/Fail: Fail | Overall Compliance: No |
| Severity Score: 33.75 | | | |

R304.5.1, R304.2.2

| Compliance | Description | Data | Compliance | Description | Data |
|---|---|---|---|---|---|
| N/A | Ramp Length (in) | 61.0 | No | Ramp Slope (%) | 17.0 |
| No | Ramp Width (in) | 47.0 | Yes | Ramp XSlope (%) | 1.3 |

Remove & Replace Entire Ramp.

Total Cost: \$ 1850.00
