# Access Compliance Report

## Public Rights-of-Way

### (Curb Ramps)

Intersection ID: 10031405	Main Street: MCALPINE_PARK_DR	Cross Street: N/A	Location: NW
ADA ID: F14C44A907A8	Ramp Type: PerpDiag	Initial Pass/Fail: Fail	Overall Compliance: No
Severity Score: 33.75			
Codes/Mitigation Info/Possible Solution		Field Measurements/Component Compliance

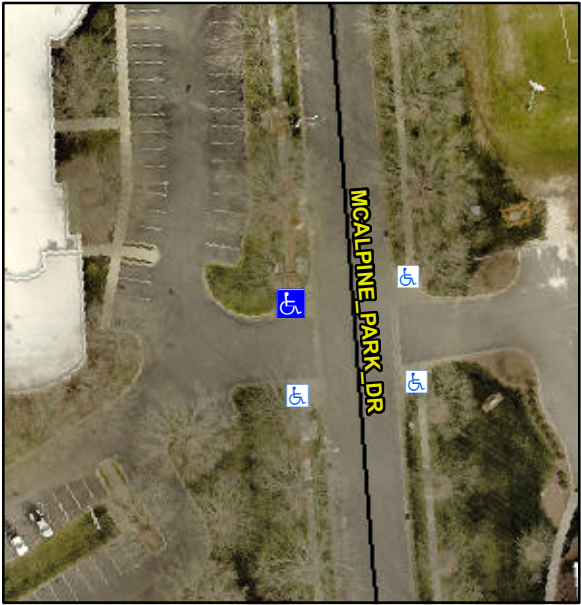
Possible Solutions:		Compliance	Description	Data	Compliance	Description	Data
	Remove & Replace Curb Ramp With Two New Directional Ramps or Equivalent.		N/A	Ramp Length (in)	65.5	No	Ramp Slope (%)	9.6
<p>Surveyor Notes:</p> <p>N/A</p> <p>PROW/ADA:</p> <p>Not Found, R304.5.1, R304.2.2, R304.5.3</p>			No	Ramp Width (in)	45.0	No	Ramp XSlope (%)	6.4
			N/A	Flare Type LT	N/A	N/A	Flare Type RT	N/A
<p>Street 1 Name</p> <p>ENTRANCE</p> <p>Stop Condition-Street 2</p> <p>None</p> <p>Street 2 Name</p> <p>MCALPINE PARK DR</p> <p>Stop Condition-Street 1</p> <p>None</p>			N/A	Flare Slope LT (%)	N/A	N/A	Flare Slope RT (%)	N/A
			N/A	Flare Traversable LT?	N/A	N/A	Flare Traversable RT?	N/A
<p>Total Cost:</p> <p>\$ 3200.00</p>			N/A	Landing Length (in)	N/A	N/A	DWS Provided?	N/A
			N/A	Landing Width (in)	N/A	N/A	DWS Contrast?	N/A
			N/A	Landing Slope (%)	N/A	N/A	DWS Length (in)	N/A
			N/A	Landing X Slope (%)	N/A	N/A	DWS Full Width?	N/A

N/A	Landing Curb? (Y/N)	N/A	N/A	DWS Offset (in)	N/A
			N/A	Shared Landing?	N/A			
			N/A	Gutter Ponding?	N/A	N/A	Gutter Slope (%)	N/A
			N/A	Gutter Lip Ht (in)	N/A	N/A	Gutter X Slope (%)	N/A
			N/A	Painted X Walk1?	No	N/A	Painted X Walk2?	No
				X Walk 1 Direction	To S		X Walk 2 Direction	To E
			N/A	X Walk 1 Width (in)	N/A	N/A	X Walk 2 Width (in)	N/A
				X Walk 1 Slope (%)	4.5		X Walk 2 Slope (%)	2.9
				X Walk 1 X Slope (%)	9.5		X Walk 2 X Slope (%)	3.7
			N/A	Ramp inside XWalk1?	N/A	N/A	Ramp inside XWalk2?	N/A
				Road Slope (%)	3.5	N/A	Clear Space?	N/A
				Road X Slope (%)	8.8	N/A	Clear Space to XWalk (in)	N/A
			N/A	Any Obstructions?	N/A	N/A	Storm Grate/Utility Hazard?	N/A
				Obstruction Type			Storm Grate/Utility Type	
			N/A			N/A		N/A
			Yes	Surface Condition? (G/P)				Good
