Access Compliance Report

Public Rights-of-Way

(Curb Ramps)

Intersection ID: 10867	Main Street: E_35TH_ST	Cross Street: THE_PLAZA	Location: W
ADA ID: F14EA956A079	Ramp Type: PerpDiag	Initial Pass/Fail: Fail	Overall Compliance: No
Severity Score: 22.5			
Codes/Mitigation Info/Possible Solution		Field Measurements/Component Compliance

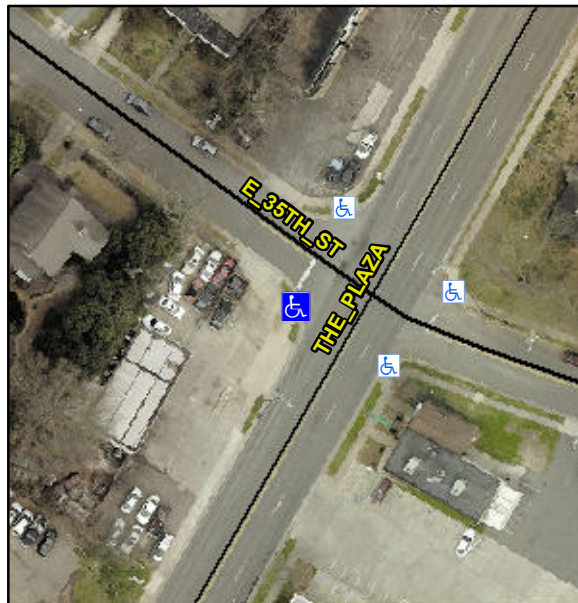
Not Found, R304.5.1, R304.2.2, R304.5.3

Compliance	Description	Data	Compliance	Description	Data
N/A	Ramp Length (in)	49.0	No	Ramp Slope (%)	9.6
No	Ramp Width (in)	42.0	No	Ramp XSlope (%)	2.8
N/A	Flare Type LT	N/A	N/A	Flare Type RT	N/A
N/A	Flare Slope LT (%)	N/A	N/A	Flare Slope RT (%)	N/A
N/A	Flare Traversable LT?	N/A	N/A	Flare Traversable RT?	N/A
N/A	Landing Length (in)	N/A	N/A	DWS Provided?	N/A
N/A	Landing Width (in)	N/A	N/A	DWS Contrast?	N/A
N/A	Landing Slope (%)	N/A	N/A	DWS Length (in)	N/A
N/A	Landing X Slope (%)	N/A	N/A	DWS Full Width?	N/A
N/A	Landing Curb? (Y/N)	N/A	N/A	DWS Offset (in)	N/A
N/A	Shared Landing?	N/A			
N/A	Gutter Ponding?	N/A	N/A	Gutter Slope (%)	N/A
N/A	Gutter Lip Ht (in)	N/A	N/A	Gutter X Slope (%)	N/A
N/A	Painted X Walk1?	No	N/A	Painted X Walk2?	No
	X Walk 1 Direction	To SE		X Walk 2 Direction	To NE
N/A	X Walk 1 Width (in)	N/A	N/A	X Walk 2 Width (in)	N/A
	X Walk 1 Slope (%)	1.2		X Walk 2 Slope (%)	1.3
	X Walk 1 X Slope (%)	2.2		X Walk 2 X Slope (%)	2.5

N/A	Ramp inside XWalk1?	N/A	N/A	Ramp inside XWalk2?	N/A
	Road Slope (%)	2.4	N/A	Clear Space?	N/A
	Road X Slope (%)	1.4	N/A	Clear Space to XWalk (in)	N/A
N/A	Any Obstructions?	N/A	N/A	Storm Grate/Utility Hazard?	N/A
	Obstruction Type			Storm Grate/Utility Type	
		N/A			N/A
			Yes	Surface Condition? (G/P)	Good

Remove & Replace Curb Ramp With Two New Directional Ramps or Equivalent.

Total Cost: \$ 3200.00
