Access Compliance Report

Public Rights-of-Way

(Curb Ramps)

Intersection ID: 7478	Main Street: STONEHURST_DR	Cross Street: SULLINS_RD	Location: S
ADA ID: F15174F4B953	Ramp Type: Perp	Initial Pass/Fail: Fail	Overall Compliance: No
			Severity Score: 1.25

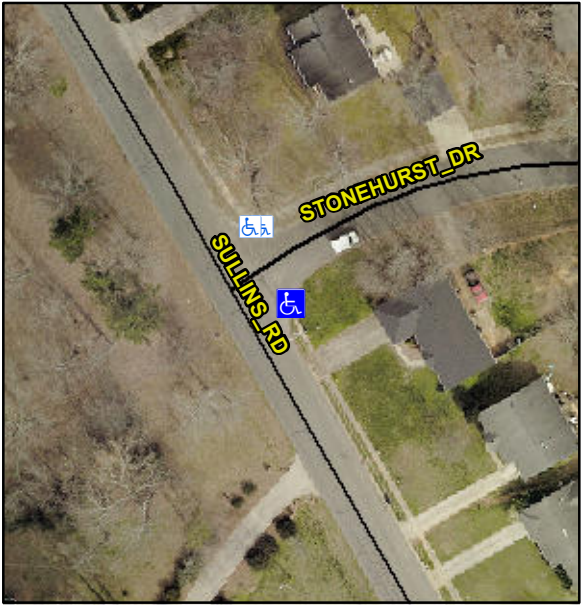
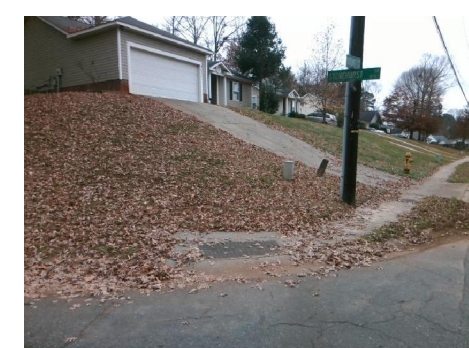
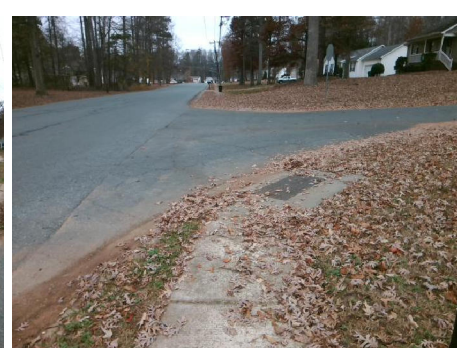
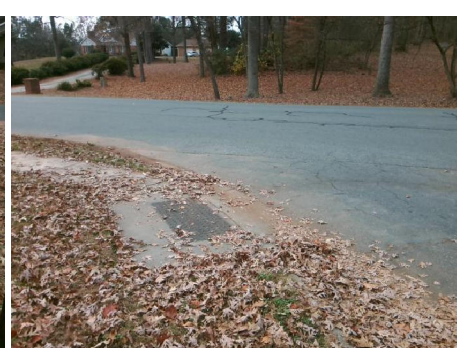
Possible Solutions:		Compliance	Description	Data
	Remove & Replace Entire Ramp.		Yes	Ramp Length (in)	51.0
			No	Ramp Width (in)	48.0
			N/A	Flare Type LT	N/A
			N/A	Flare Slope LT (%)	N/A
			N/A	Flare Traversable LT?	N/A
			N/A	Landing Length (in)	N/A
			N/A	Landing Width (in)	N/A
			N/A	Landing Slope (%)	N/A
			N/A	Landing X Slope (%)	N/A
<p>Surveyor Notes:</p> <p>N/A</p> <p>PROW/ADA:</p> <p>Not Found, R304.5.3</p>			N/A	Flare Type RT	N/A
			N/A	Flare Slope RT (%)	N/A
			N/A	Flare Traversable RT?	N/A
			N/A	DWS Provided?	N/A
			N/A	DWS Contrast?	N/A
			N/A	DWS Length (in)	N/A
			N/A	DWS Full Width?	N/A
			N/A	DWS Offset (in)	N/A
			N/A	Gutter Ponding?	N/A
			N/A	Gutter Lip Ht (in)	N/A
			No	Painted X Walk1?	N/A
			To N	X Walk 1 Direction	N/A
			N/A	X Walk 1 Width (in)	N/A

3.9	X Walk 1 Slope (%)	N/A
			1.3	X Walk 1 X Slope (%)	N/A
			N/A	Ramp inside XWalk1?	N/A
			N/A	Road Slope (%)	N/A
			N/A	Road X Slope (%)	N/A
			N/A	Any Obstructions?	N/A
				Obstruction Type	N/A
Total Cost:		\$ 1850.00	N/A	Clear Space?	N/A
			N/A	Clear Space to XWalk (in)	N/A
			N/A	Storm Grate/Utility Hazard?	N/A
			N/A	Storm Grate/Utility Type	N/A
			Yes	Surface Condition? (G/P)	Good
