# Access Compliance Report

## Public Rights-of-Way

### (Curb Ramps)

| Intersection ID: 2813 | Main Street: RIDGEFIELD_DR | Cross Street: SWANSTON_DR | Location: SE |

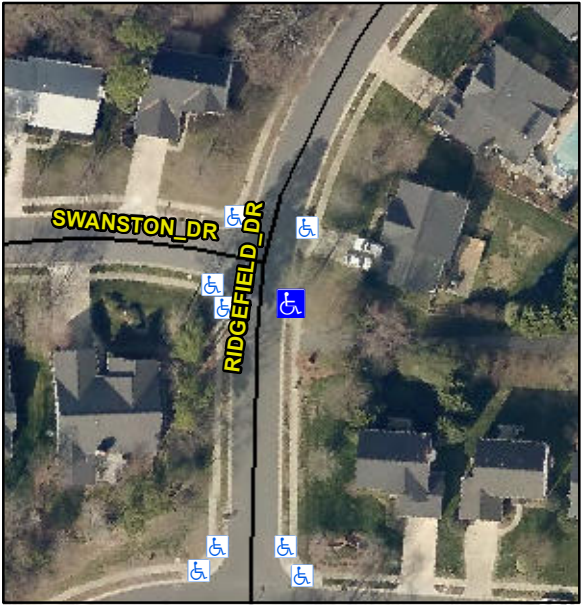
| ADA ID: F15409F52C97 | Ramp Type: Perp | Initial Pass/Fail: Fail | Overall Compliance: No |

| <p>Surveyor Notes:</p> <p>N/A</p> <p>PROW/ADA:</p> <p>R304.5.1, R304.2.2</p> | | N/A | Ramp Length (in) | 97.0 | No | Ramp Slope (%) | 10.1 |
| | | No | Ramp Width (in) | 36.0 | Yes | Ramp XSlope (%) | 1.7 |

| | Remove & Replace Entire Ramp. | Compliance | Description | Data | Compliance | Description | Data |
