# Access Compliance Report

## Public Rights-of-Way

### (Curb Ramps)

Intersection ID: 8700	Main Street: L_D PARKER DR	Cross Street: HOLLAND AV	Location: NE
ADA ID: F15920B9FF13	Ramp Type: PerpDiag	Initial Pass/Fail: Fail	Overall Compliance: No
Severity Score: 35			
Codes/Mitigation Info/Possible Solution		Field Measurements/Component Compliance

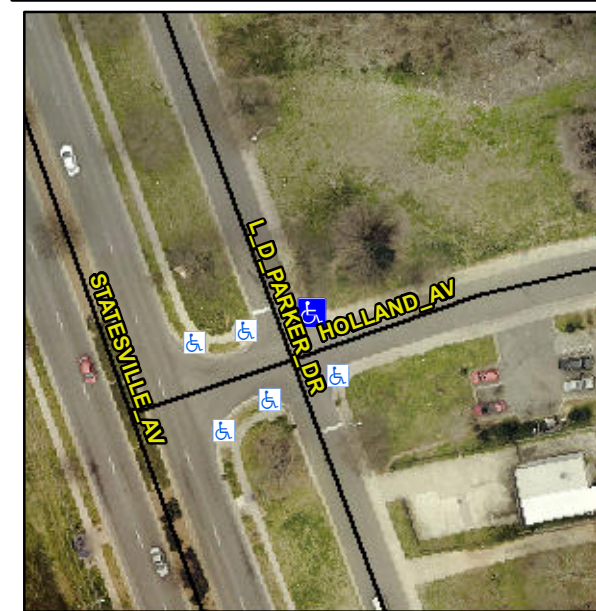
**Not Found, R304.5.1**

Compliance	Description	Data	Compliance	Description	Data
N/A	Ramp Length (in)	59.5	Yes	Ramp Slope (%)	5.5
No	Ramp Width (in)	28.5	Yes	Ramp XSlope (%)	0.7
N/A	Flare Type LT	N/A	N/A	Flare Type RT	N/A
N/A	Flare Slope LT (%)	N/A	N/A	Flare Slope RT (%)	N/A
N/A	Flare Traversable LT?	N/A	N/A	Flare Traversable RT?	N/A
N/A	Landing Length (in)	N/A	N/A	DWS Provided?	N/A
N/A	Landing Width (in)	N/A	N/A	DWS Contrast?	N/A
N/A	Landing Slope (%)	N/A	N/A	DWS Length (in)	N/A
N/A	Landing X Slope (%)	N/A	N/A	DWS Full Width?	N/A
N/A	Landing Curb? (Y/N)	N/A	N/A	DWS Offset (in)	N/A
N/A	Shared Landing?	N/A			
N/A	Gutter Ponding?	N/A	N/A	Gutter Slope (%)	N/A
N/A	Gutter Lip Ht (in)	N/A	N/A	Gutter X Slope (%)	N/A
N/A	Painted X Walk1?	No	N/A	Painted X Walk2?	No
	X Walk 1 Direction	To W		X Walk 2 Direction	To S
N/A	X Walk 1 Width (in)	N/A	N/A	X Walk 2 Width (in)	N/A
	X Walk 1 Slope (%)	1.9		X Walk 2 Slope (%)	1.5
	X Walk 1 X Slope (%)	0.4		X Walk 2 X Slope (%)	1.5

N/A	Ramp inside XWalk1?	N/A	N/A	Ramp inside XWalk2?	N/A
	Road Slope (%)	0.6	N/A	Clear Space?	N/A
	Road X Slope (%)	1.7	N/A	Clear Space to XWalk (in)	N/A
N/A	Any Obstructions?	N/A	N/A	Storm Grate/Utility Hazard?	N/A
	Obstruction Type			Storm Grate/Utility Type	
		N/A			N/A
		Yes		Surface Condition? (G/P)	Good

**Remove & Replace Curb Ramp With Two New Directional Ramps or Equivalent.**

Total Cost: \$ 3200.00
