# Access Compliance Report

## Public Rights-of-Way

### (Curb Ramps)

| Intersection ID: 44467 | Main Street: BUCKHORN_ST | Cross Street: ROSBERG_LN | Location: NW |

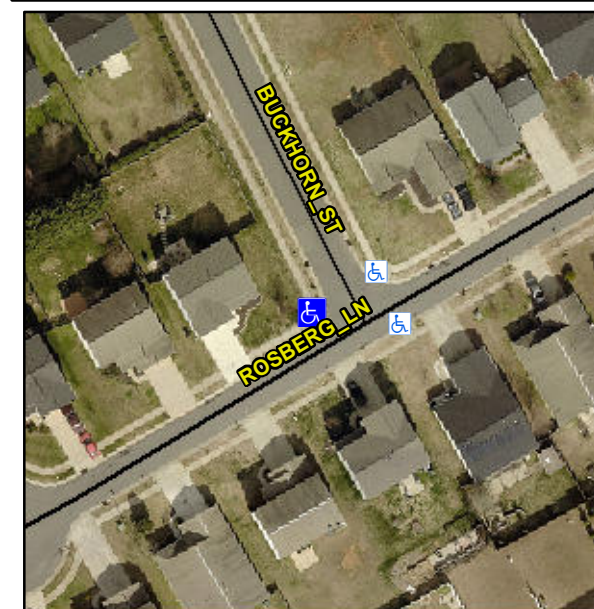
| ADA ID: F179A32445C3 | Ramp Type: PerpDiag | Initial Pass/Fail: Fail | Overall Compliance: No |

**Not Found, R304.5.1**

| Compliance | Description | Data | Compliance | Description | Data |
|---|---|---|---|---|---|
| No | Ramp Width (in) | 32.0 | Yes | Ramp XSlope (%) | 0.3 |

**Remove & Replace Curb Ramp With Two New Directional Ramps or Equivalent.**

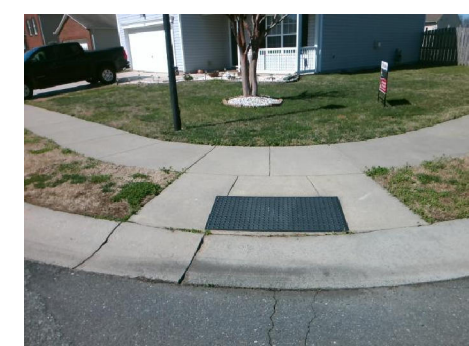
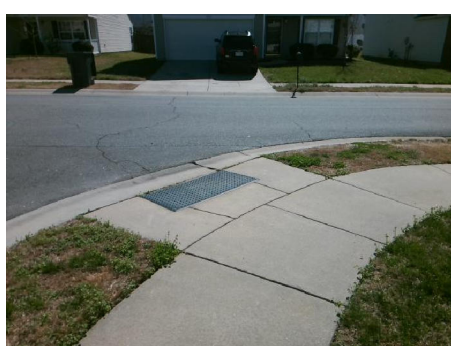
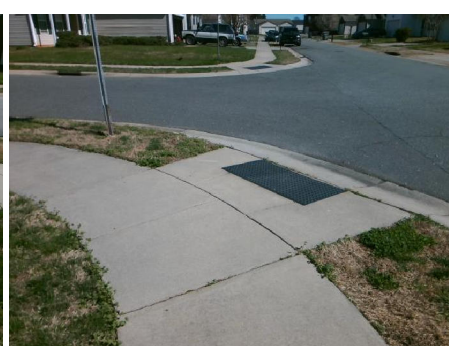
| Compliance | Description | Data | Compliance | Description | Data |
|---|---|---|---|---|---|
| N/A | Ramp Length (in) | 48.5 | Yes | Ramp Slope (%) | 7.2 |
| | | | Yes | Surface Condition? (G/P) | Good |
