Access Compliance Report Public Rights-of-Way (Curb Ramps)

Intersection ID: 16485 Main Street: PARK RD Cross Street: PRINCETON AV Location:									ee.
Intersection ID: 16485					—	Location:	SE		
ADA ID: F194C6A329B1 Ramp Type: PerpDiag			Initial Pa	nitial Pass/Fail: Fail Overall Compliance: No				o Severity Score:	33.75
Codes/Mitigation Info/Possible Solution				Field Measurements/Component Compliance					
In Spinson of		Possible Solutions:		Compliance Description			Data Compliance Description		Data
		Remove & Replace Curb Ramp W	/ith	N/A	Ramp Length (in)	50.0	No	Ramp Slope (%)	10.3
		Two New Directional Ramps or		No	Ramp Width (in)	47.5	No	Ramp XSlope (%)	5.2
		Equivalent.		N/A	Flare Type LT	N/A	N/A	Flare Type RT	N/A
				N/A	Flare Slope LT (%)	N/A	N/A	Flare Slope RT (%)	N/A
A CONTRACTOR				N/A	Flare Traversable LT?	N/A	N/A	Flare Traversable RT?	N/A
A TIMUSA	NGETON_AV			N/A	Landing Length (in)	N/A	N/A	DWS Provided?	N/A
	CHEUCAL COL	Surveyor Notes:		N/A	Landing Width (in)	N/A	N/A	DWS Contrast?	N/A

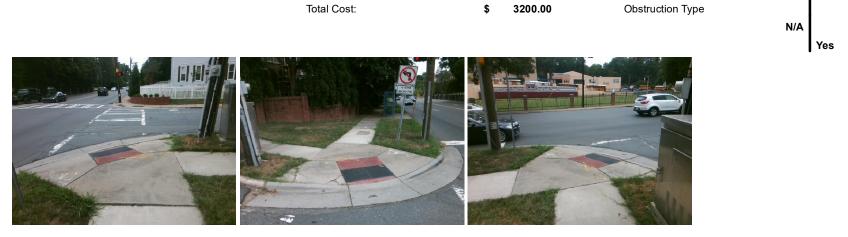
ALL STREET	N/A		N/A	Landing Slope (%)	N/A	N/A	DWS Length (in)	N/A
				N/A	Landing X Slope (%)	N/A	N/A	DWS Full Width?	N/A
				N/A	Landing Curb? (Y/N)	N/A	N/A	DWS Offset (in)	N/A
				N/A	Shared Landing?	N/A			
	A CONTRACT	PROW/ADA:		N/A	Gutter Ponding?	N/A	N/A	Gutter Slope (%)	N/A
	Not Found, R304.5.1, R304.2.2,		N/A	Gutter Lip Ht (in)	N/A	N/A	Gutter X Slope (%)	N/A	
R304.5.3				N/A	Painted X Walk1?	Yes	N/A	Painted X Walk2?	No
					X Walk 1 Direction	To N		X Walk 2 Direction	To W
				N/A	X Walk 1 Width (in)	105.0	N/A	X Walk 2 Width (in)	N/A
Street 1 Name	PRINCETON AV				X Walk 1 Slope (%)	8.1		X Walk 2 Slope (%)	4.0
Stop Condition-Street 2	Signal				X Walk 1 X Slope (%)	4.4		X Walk 2 X Slope (%)	4.1
Street 2 Name	PARK RD			N/A	Ramp inside XWalk1?	Yes	N/A	Ramp inside XWalk2?	N/A
Stop Condition-Street 1	None				Road Slope (%)	6.0	N/A	Clear Space?	N/A
					Road X Slope (%)	6.7	N/A	Clear Space to XWalk (in)	N/A

N/A	Any Obstructions?	N/A	N/A	Storm Grate/Utility Hazard?	N/A
		Total Cost: \$ 32	200.00		Obstruction Type			Storm Grate/Utility Type	
						N/A			N/A
