## Access Compliance Report Public Rights-of-Way (Curb Ramps)

Intersection ID: 14070 Main Street: HARRISBURG\_RD Cross Street: PENCE\_RD Location: SE

ADA ID: F19AFF4A7200 Ramp Type: Para Initial Pass/Fail: Fail Overall Compliance: No Severity Score: 13.75

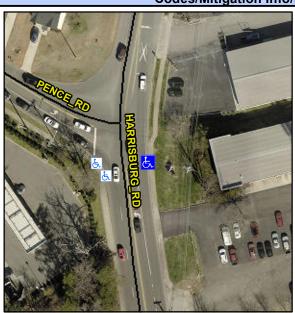
No
No
No
No
No
No
N/A
Surveyor Notes:

RT RP < 5%

R304.3.2, R304.5.3

Field Measurements/Component Compliance					
Compliance Description		Data	Compliance Description		Data
N/A	Ramp Length LT (in)	71.5	N/A	Ramp Length RT (in)	69.5
Yes	Ramp Width LT (in)	60.5	Yes	Ramp Width RT (in)	60.0
No	Ramp Slope LT (%)	8.4	Yes	Ramp Slope RT (%)	2.7
No	Ramp XSlope LT (%)	3.0	No	Ramp XSlope RT (%)	3.3
N/A	Landing Length (in)	N/A	N/A	DWS Provided?	N/A
N/A	Landing Width (in)	N/A	N/A	DWS Contrast?	N/A
N/A	Landing Slope (%)	N/A	N/A	DWS Length (in)	N/A
N/A	Landing X Slope (%)	N/A	N/A	DWS Full Width?	N/A
N/A	Landing Curb? (Y/N)	N/A	N/A	DWS Offset (in)	N/A
N/A	Shared Landing?	N/A			
N/A	Gutter Ponding?	N/A	N/A	Gutter Slope (%)	N/A
N/A	Gutter Lip Ht (in)	N/A	N/A	Gutter X Slope (%)	N/A
N/A	Painted X Walk1?	No	N/A	Painted X Walk2?	N/A
	X Walk 1 Direction	To W		X Walk 2 Direction	N/A
N/A	X Walk 1 Width (in)	N/A	N/A	X Walk 2 Width (in)	N/A
	X Walk 1 Slope (%)	3.6		X Walk 2 Slope (%)	N/A
	X Walk 1 X Slope (%)	4.0		X Walk 2 X Slope (%)	N/A

N/A	Ramp inside XWalk1?	N/A	N/A	Ramp inside XWalk2?	N/A
	Road Slope (%)	N/A	N/A	Clear Space?	N/A
	Road X Slope (%)	N/A	N/A	Clear Space to XWalk (in)	N/A
N/A	Any Obstructions?	N/A	N/A	Storm Grate/Utility Hazard?	N/A
	Obstruction Type			Storm Grate/Utility Type	
		N/A			N/A
			Yes	Surface Condition? (G/P)	Good
			N/A	Curb Slope (%)	8.9
		,	-		
The state of the s	THE RESERVE AND ADDRESS OF THE PARTY OF THE

Possible Solutions:

Remove & Replace Entire Ramp.

Total Cost: \$ 1600.00
