# Access Compliance Report

## Public Rights-of-Way

### (Curb Ramps)

Intersection ID: 3757	Main Street: DAVIS_LAKE_PY	Cross Street: POPLAR_GROVE_DR	Location: SE
ADA ID: F19D3BFF0ECC	Ramp Type: Perp	Initial Pass/Fail: Fail	Overall Compliance: No
Severity Score: 26.25			
Codes/Mitigation Info/Possible Solution		Field Measurements/Component Compliance

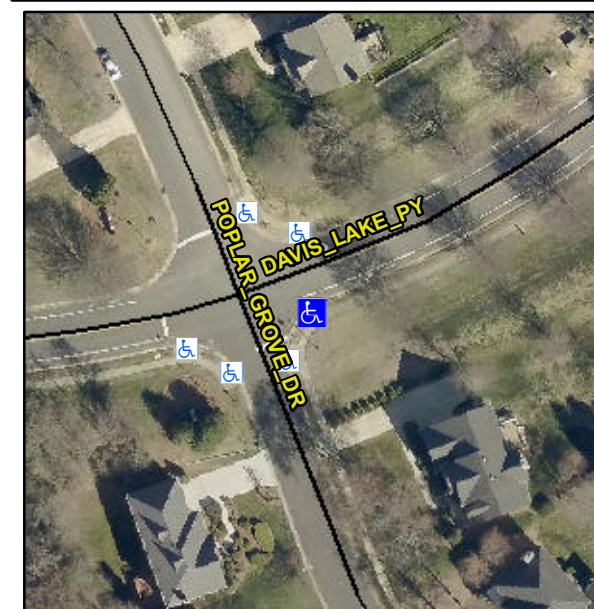
**Not Found, R304.2.2, R304.5.3**

Compliance	Description	Data	Compliance	Description	Data
N/A	Ramp Length (in)	48.0	No	Ramp Slope (%)	16.5
Yes	Ramp Width (in)	48.0	No	Ramp XSlope (%)	4.1
N/A	Flare Type LT	N/A	N/A	Flare Type RT	N/A
N/A	Flare Slope LT (%)	N/A	N/A	Flare Slope RT (%)	N/A
N/A	Flare Traversable LT?	N/A	N/A	Flare Traversable RT?	N/A
N/A	Landing Length (in)	N/A	N/A	DWS Provided?	N/A
N/A	Landing Width (in)	N/A	N/A	DWS Contrast?	N/A
N/A	Landing Slope (%)	N/A	N/A	DWS Length (in)	N/A
N/A	Landing X Slope (%)	N/A	N/A	DWS Full Width?	N/A
N/A	Landing Curb? (Y/N)	N/A	N/A	DWS Offset (in)	N/A
N/A	Shared Landing?	N/A			
N/A	Gutter Ponding?	N/A	N/A	Gutter Slope (%)	N/A
N/A	Gutter Lip Ht (in)	N/A	N/A	Gutter X Slope (%)	N/A
N/A	Painted X Walk1?	No	N/A	Painted X Walk2?	N/A
	X Walk 1 Direction	To N		X Walk 2 Direction	N/A
N/A	X Walk 1 Width (in)	N/A	N/A	X Walk 2 Width (in)	N/A
	X Walk 1 Slope (%)	4.0		X Walk 2 Slope (%)	N/A
	X Walk 1 X Slope (%)	0.1		X Walk 2 X Slope (%)	N/A

N/A	Ramp inside XWalk1?	N/A	N/A	Ramp inside XWalk2?	N/A
	Road Slope (%)	N/A	N/A	Clear Space?	N/A
	Road X Slope (%)	N/A	N/A	Clear Space to XWalk (in)	N/A
N/A	Any Obstructions?	N/A	N/A	Storm Grate/Utility Hazard?	N/A
	Obstruction Type			Storm Grate/Utility Type	
		N/A			N/A
			Yes	Surface Condition? (G/P)	Good

Possible Solutions:

**Remove & Replace Entire Ramp.**
