Access Compliance Report

Public Rights-of-Way

(Curb Ramps)

Intersection ID: 28251	Main Street: PEMSWOOD_ST	Cross Street: SUMMER CLUB_RD	Location: SW
ADA ID: F1A0F8593F8E	Ramp Type: PerpDiag	Initial Pass/Fail: Fail	Overall Compliance: No
Severity Score: 35			
Codes/Mitigation Info/Possible Solution		Field Measurements/Component Compliance

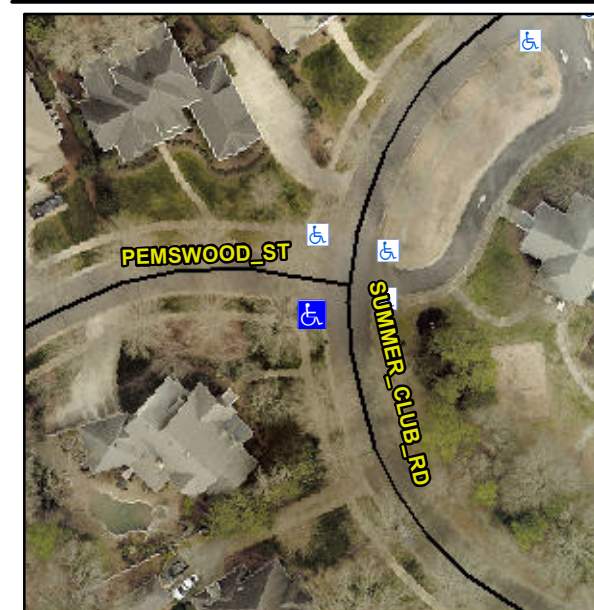
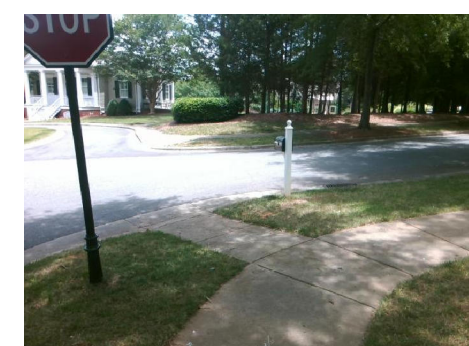
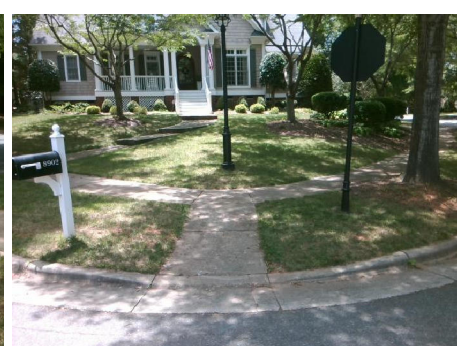
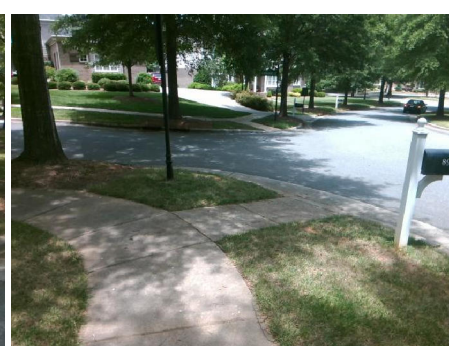
R304.5.1, R304.2.2, R304.5.3

Compliance	Description	Data	Compliance	Description	Data
N/A	Ramp Length (in)	97.0	No	Ramp Slope (%)	15.8
No	Ramp Width (in)	46.0	No	Ramp XSlope (%)	2.1
N/A	Flare Type LT	N/A	N/A	Flare Type RT	N/A
N/A	Flare Slope LT (%)	N/A	N/A	Flare Slope RT (%)	N/A
N/A	Flare Traversable LT?	N/A	N/A	Flare Traversable RT?	N/A
N/A	Landing Length (in)	N/A	N/A	DWS Provided?	N/A
N/A	Landing Width (in)	N/A	N/A	DWS Contrast?	N/A
N/A	Landing Slope (%)	N/A	N/A	DWS Length (in)	N/A
N/A	Landing X Slope (%)	N/A	N/A	DWS Full Width?	N/A
N/A	Landing Curb? (Y/N)	N/A	N/A	DWS Offset (in)	N/A
N/A	Shared Landing?	N/A			
N/A	Gutter Ponding?	N/A	N/A	Gutter Slope (%)	N/A
N/A	Gutter Lip Ht (in)	N/A	N/A	Gutter X Slope (%)	N/A
N/A	Painted X Walk1?	No	N/A	Painted X Walk2?	No
	X Walk 1 Direction	To E		X Walk 2 Direction	To N
N/A	X Walk 1 Width (in)	N/A	N/A	X Walk 2 Width (in)	N/A
	X Walk 1 Slope (%)	1.1		X Walk 2 Slope (%)	5.3
	X Walk 1 X Slope (%)	5.1		X Walk 2 X Slope (%)	1.6

N/A	Ramp inside XWalk1?	N/A	N/A	Ramp inside XWalk2?	N/A
	Road Slope (%)	3.3	N/A	Clear Space?	N/A
	Road X Slope (%)	2.3	N/A	Clear Space to XWalk (in)	N/A
N/A	Any Obstructions?	N/A	N/A	Storm Grate/Utility Hazard?	N/A
	Obstruction Type			Storm Grate/Utility Type	
		N/A			N/A
			Yes	Surface Condition? (G/P)	Good

Remove & Replace Curb Ramp With Two New Directional Ramps or Equivalent.
