Access Compliance Report Public Rights-of-Way (Curb Ramps)

Intersection ID: 10365 Main Street: N_CHURCH_ST Cross Street: W_24TH_ST Location: E

ADA ID: F1A66E421FE0 Ramp Type: Combination1 Initial Pass/Fail: Pass Overall Compliance: No Severity Score: 0.25

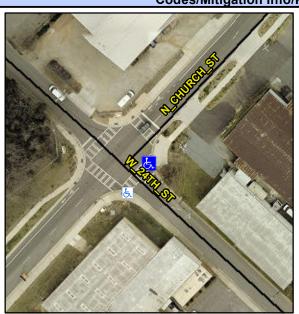
GTR GAP 1.5", RT RP < 5%

Not Found, R304.5.3, R304.2.1,
R304.2.2-Perp, R304.3.2-Para

Possible Solutions:

Remove & Replace Entire Ramp.
Remove & Replace Sidewalk.
Remove & Replace Gutter.
