Access Compliance Report Public Rights-of-Way (Curb Ramps)

Intersection ID: 10011741 Main Street: N_SHARON_AMITY_RD Cross Street: N/A Location: SE

ADA ID: F1A96673BEF6 Ramp Type: PerpDiag Initial Pass/Fail: Fail Overall Compliance: No Severity Score: 33.75

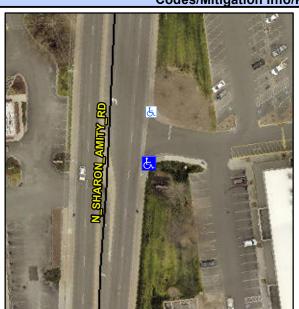
Not Found, R304.5.1, R304.5.3

Field Measurements/Component Compliance					
Co	Compliance Description		Comp	oliance Description	Data
N/	A Ramp Length (in)	59.0	Yes	Ramp Slope (%)	6.1
No	Ramp Width (in)	40.0	No	Ramp XSlope (%)	7.3
N/	A Flare Type LT	N/A	N/A	Flare Type RT	N/A
N/	A Flare Slope LT (%)	N/A	N/A	Flare Slope RT (%)	N/A
N/	A Flare Traversable LT?	N/A	N/A	Flare Traversable RT?	N/A
N/	A Landing Length (in)	N/A	N/A	DWS Provided?	N/A
N/	A Landing Width (in)	N/A	N/A	DWS Contrast?	N/A
N/	A Landing Slope (%)	N/A	N/A	DWS Length (in)	N/A
N/	A Landing X Slope (%)	N/A	N/A	DWS Full Width?	N/A
N/	A Landing Curb? (Y/N)	N/A	N/A	DWS Offset (in)	N/A
N/	A Shared Landing?	N/A			
N/	A Gutter Ponding?	N/A	N/A	Gutter Slope (%)	N/A
N/	A Gutter Lip Ht (in)	N/A	N/A	Gutter X Slope (%)	N/A
N/	A Painted X Walk1?	No	N/A	Painted X Walk2?	No
	X Walk 1 Direction	To N		X Walk 2 Direction	To W
N/	A X Walk 1 Width (in)	N/A	N/A	X Walk 2 Width (in)	N/A
	X Walk 1 Slope (%)	3.6		X Walk 2 Slope (%)	2.3

X Walk 1 X Slope (%)	7.3		X Walk 2 X Slope (%)	1.2
N/	A Ramp inside XWalk1?	N/A	N/A	Ramp inside XWalk2?	N/A
	Road Slope (%)	1.9	N/A	Clear Space?	N/A
	Road X Slope (%)	6.1	N/A	Clear Space to XWalk (in)	N/A
N/	A Any Obstructions?	N/A	N/A	Storm Grate/Utility Hazard?	N/A
	Obstruction Type			Storm Grate/Utility Type	
		N/A			N/A
			Yes	Surface Condition? (G/P)	Good
	77V . 1		-	. ,

Remove & Replace Curb Ramp With Two New Directional Ramps or Equivalent.
