# Access Compliance Report

## Public Rights-of-Way

### (Curb Ramps)

| Intersection ID: 29145 | Main Street: CRAWFORD_BROOK_LN | Cross Street: DEATON_HILL_DR | Location: NE |

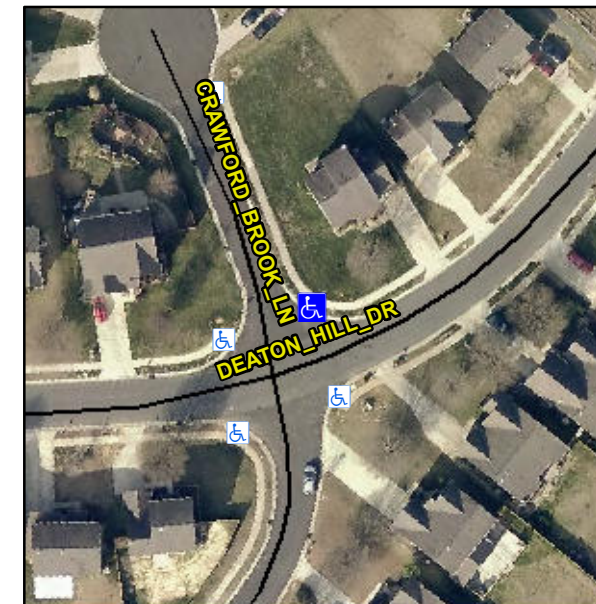
**Not Found, R304.2.1, R304.2.2-Perp, R304.3.2-Para, R304.5.3, R305.1.4, R304.5.4**

| Compliance | Description | Data | Compliance | Description | Data |
|---|---|---|---|---|---|
| No | Landing Length (in) | 46.0 | Yes | DWS Provided? | Yes |
| No | Landing Slope (%) | 5.3 | No | DWS Length (in) | 23.5 |
| No | Landing X Slope (%) | 2.6 | Yes | DWS Full Width? | Yes |
| Yes | Gutter Ponding? | No | No | Gutter Slope (%) | 5.4 |

**Remove & Replace Curb Ramp With Two New Directional Ramps or Equivalent. Remove & Replace Gutter.**
