| Intersection ID: 14439 | Main Street: S_TORRENCE_ST | Cross Street: ELLISON_ST | Location: | E |
| ADA ID: F1C5F688718D | Ramp Type: Perp | Initial Pass/Fail: Fail | Overall Compliance: No | Severity Score: 25 |

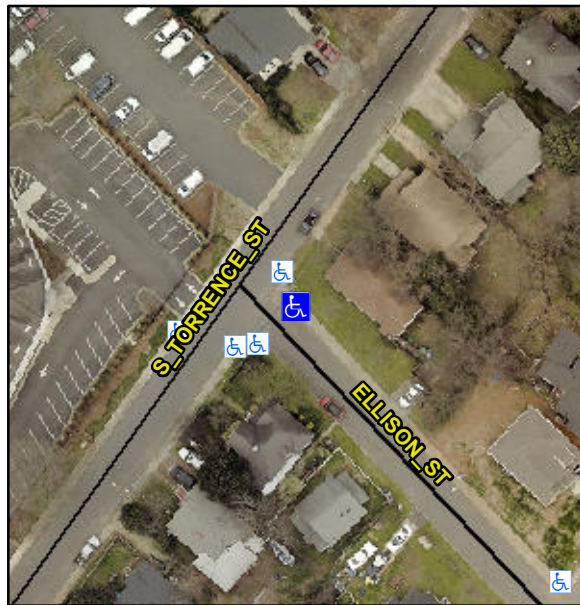
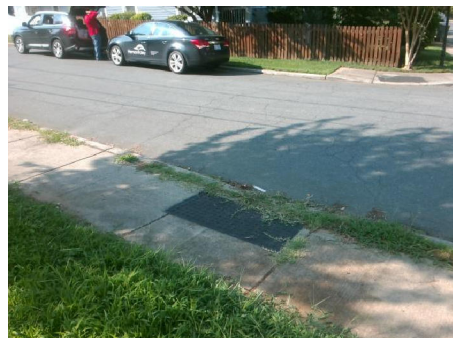
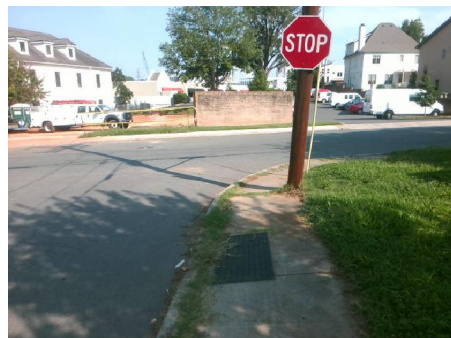
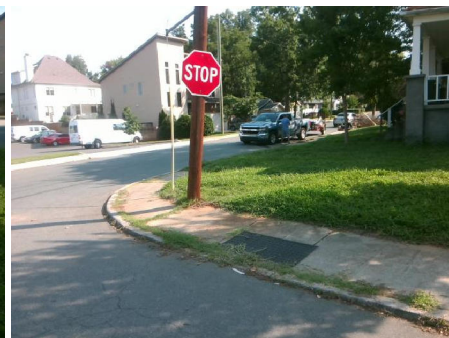
### R304.2.2

| Compliance | Description | Data | Compliance | Description | Data |
|---|---|---|---|---|---|
| N/A | Ramp Length (in) | 54.0 | No | Ramp Slope (%) | 13.1 |

### Remove & Replace Entire Ramp.

**\$ 1850.00**
