# Access Compliance Report

## Public Rights-of-Way

### (Curb Ramps)

| Intersection ID: 2606 | Main Street: CROWNVISTA_DR | Cross Street: FAIRVISTA_DR | Location: W |

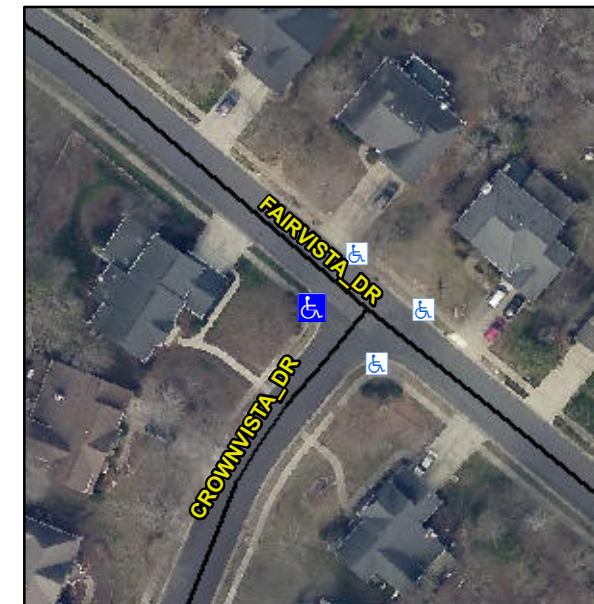
| ADA ID: F1C844B1016B | Ramp Type: PerpDiag | Initial Pass/Fail: Fail | Overall Compliance: No |

**R304.5.1, R304.5.3**

| Compliance | Description | Data | Compliance | Description | Data |
|---|---|---|---|---|---|
| N/A | Ramp Length (in) | 48.0 | Yes | Ramp Slope (%) | 6.8 |
| No | Ramp Width (in) | 47.0 | No | Ramp XSlope (%) | 3.6 |

**Remove & Replace Curb Ramp With Two New Directional Ramps or Equivalent.**

Total Cost: \$ 3200.00
