# Access Compliance Report

## Public Rights-of-Way

### (Curb Ramps)

Intersection ID: 11685	Main Street: E_19TH_ST	Cross Street: SEIGLE_AV	Location: W
ADA ID: F1D1CDC8C13D	Ramp Type: Perp	Initial Pass/Fail: Fail	Overall Compliance: No
Severity Score: 21.25			
Codes/Mitigation Info/Possible Solution		Field Measurements/Component Compliance

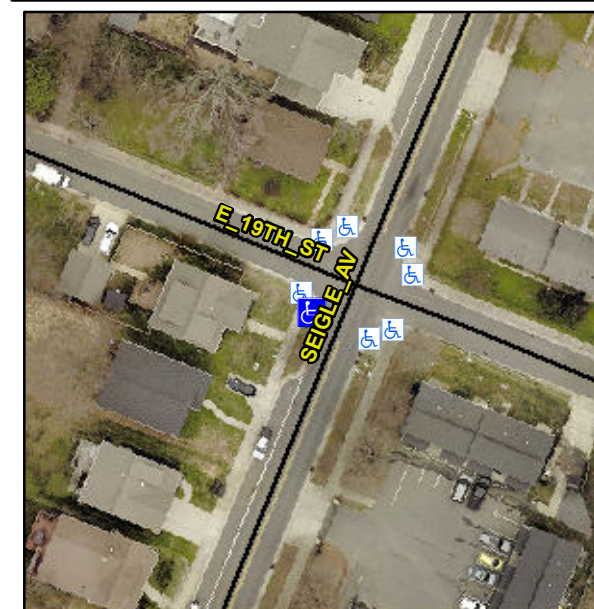
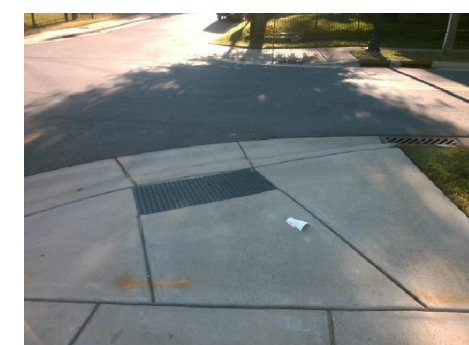
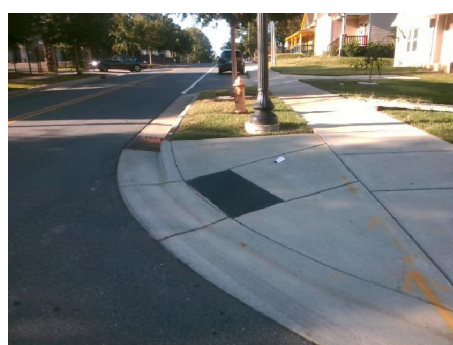
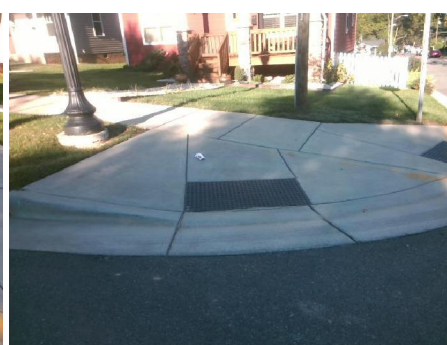
**Not Found, R304.5.1, R304.5.3**

Compliance	Description	Data	Compliance	Description	Data
N/A	Ramp Length (in)	64.0	Yes	Ramp Slope (%)	7.3
No	Ramp Width (in)	47.5	No	Ramp XSlope (%)	6.6
N/A	Flare Type LT	N/A	N/A	Flare Type RT	N/A
N/A	Flare Slope LT (%)	N/A	N/A	Flare Slope RT (%)	N/A
N/A	Flare Traversable LT?	N/A	N/A	Flare Traversable RT?	N/A
N/A	Landing Length (in)	N/A	N/A	DWS Provided?	N/A
N/A	Landing Width (in)	N/A	N/A	DWS Contrast?	N/A
N/A	Landing Slope (%)	N/A	N/A	DWS Length (in)	N/A
N/A	Landing X Slope (%)	N/A	N/A	DWS Full Width?	N/A
N/A	Landing Curb? (Y/N)	N/A	N/A	DWS Offset (in)	N/A
N/A	Shared Landing?	N/A			
N/A	Gutter Ponding?	N/A	N/A	Gutter Slope (%)	N/A
N/A	Gutter Lip Ht (in)	N/A	N/A	Gutter X Slope (%)	N/A
N/A	Painted X Walk1?	No	N/A	Painted X Walk2?	N/A
	X Walk 1 Direction	To SE		X Walk 2 Direction	N/A
N/A	X Walk 1 Width (in)	N/A	N/A	X Walk 2 Width (in)	N/A
	X Walk 1 Slope (%)	5.8		X Walk 2 Slope (%)	N/A
	X Walk 1 X Slope (%)	2.7		X Walk 2 X Slope (%)	N/A

N/A	Ramp inside XWalk1?	N/A	N/A	Ramp inside XWalk2?	N/A
	Road Slope (%)	N/A	N/A	Clear Space?	N/A
	Road X Slope (%)	N/A	N/A	Clear Space to XWalk (in)	N/A
N/A	Any Obstructions?	N/A	N/A	Storm Grate/Utility Hazard?	N/A
	Obstruction Type			Storm Grate/Utility Type	
		N/A			N/A
			Yes	Surface Condition? (G/P)	Good

**Remove & Replace Entire Ramp.**
