Access Compliance Report

Public Rights-of-Way

(Curb Ramps)

Intersection ID: 27350	Main Street: BALLANVILLA_DR	Cross Street: BALLANTYNE_TRACE_CT	Location: SE
ADA ID: F1D5774B324A	Ramp Type: PerpDiag	Initial Pass/Fail: Fail	Overall Compliance: No
Severity Score: 18.75			
Codes/Mitigation Info/Possible Solution		Field Measurements/Component Compliance

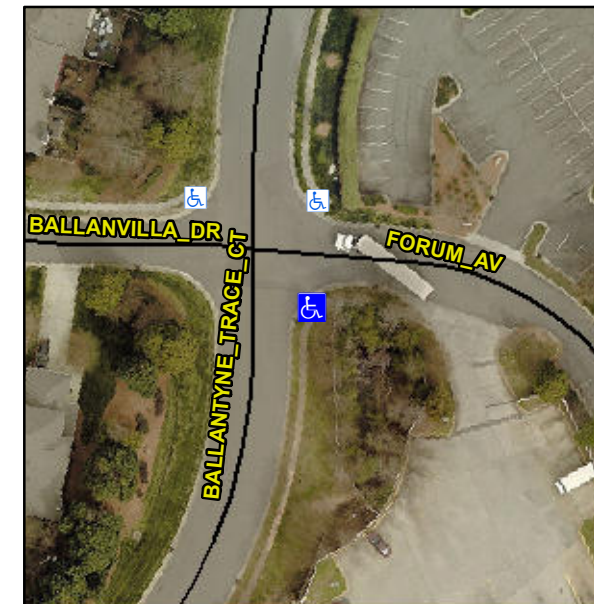
Not Found, R304.5.1, R304.5.3

Compliance	Description	Data	Compliance	Description	Data
N/A	Ramp Length (in)	96.0	Yes	Ramp Slope (%)	7.5
No	Ramp Width (in)	33.5	No	Ramp XSlope (%)	2.3
N/A	Flare Type LT	N/A	N/A	Flare Type RT	N/A
N/A	Flare Slope LT (%)	N/A	N/A	Flare Slope RT (%)	N/A
N/A	Flare Traversable LT?	N/A	N/A	Flare Traversable RT?	N/A
N/A	Landing Length (in)	N/A	N/A	DWS Provided?	N/A
N/A	Landing Width (in)	N/A	N/A	DWS Contrast?	N/A
N/A	Landing Slope (%)	N/A	N/A	DWS Length (in)	N/A
N/A	Landing X Slope (%)	N/A	N/A	DWS Full Width?	N/A
N/A	Landing Curb? (Y/N)	N/A	N/A	DWS Offset (in)	N/A
N/A	Shared Landing?	N/A			
N/A	Gutter Ponding?	N/A	N/A	Gutter Slope (%)	N/A
N/A	Gutter Lip Ht (in)	N/A	N/A	Gutter X Slope (%)	N/A
N/A	Painted X Walk1?	No	N/A	Painted X Walk2?	No
	X Walk 1 Direction	To N		X Walk 2 Direction	To W
N/A	X Walk 1 Width (in)	N/A	N/A	X Walk 2 Width (in)	N/A
	X Walk 1 Slope (%)	3.1		X Walk 2 Slope (%)	1.1
	X Walk 1 X Slope (%)	1.2		X Walk 2 X Slope (%)	2.5

N/A	Ramp inside XWalk1?	N/A	N/A	Ramp inside XWalk2?	N/A
	Road Slope (%)	1.2	N/A	Clear Space?	N/A
	Road X Slope (%)	4.1	N/A	Clear Space to XWalk (in)	N/A
N/A	Any Obstructions?	N/A	N/A	Storm Grate/Utility Hazard?	N/A
	Obstruction Type			Storm Grate/Utility Type	
		N/A			N/A
		Yes		Surface Condition? (G/P)	Good

Remove & Replace Curb Ramp With Two New Directional Ramps or Equivalent.
