Access Compliance Report

Public Rights-of-Way

(Curb Ramps)

Intersection ID: 15545	Main Street: ELMHURST_RD	Cross Street: POINDEXTER_DR	Location: W
ADA ID: F1D7A89B6815	Ramp Type: PerpDiag	Initial Pass/Fail: Fail	Overall Compliance: No
Severity Score: 25			
Codes/Mitigation Info/Possible Solution		Field Measurements/Component Compliance

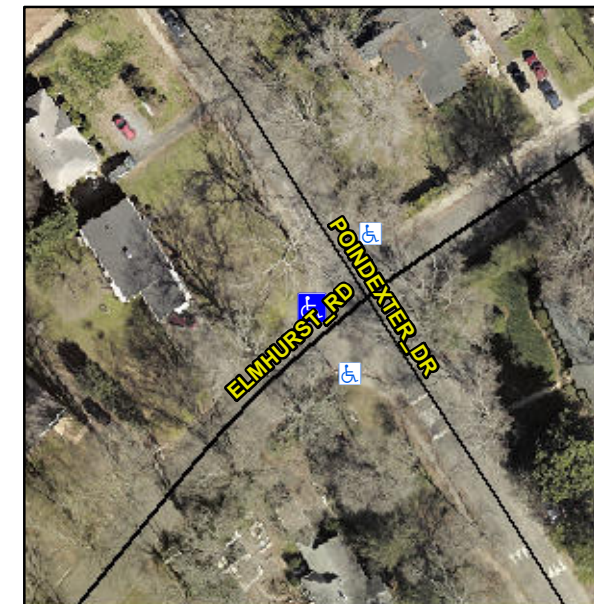
Not Found, R304.2.2, R304.5.3

Compliance	Description	Data	Compliance	Description	Data
N/A	Ramp Length (in)	59.0	No	Ramp Slope (%)	10.2
Yes	Ramp Width (in)	48.0	No	Ramp XSlope (%)	6.0
N/A	Flare Type LT	N/A	N/A	Flare Type RT	N/A
N/A	Flare Slope LT (%)	N/A	N/A	Flare Slope RT (%)	N/A
N/A	Flare Traversable LT?	N/A	N/A	Flare Traversable RT?	N/A
N/A	Landing Length (in)	N/A	N/A	DWS Provided?	N/A
N/A	Landing Width (in)	N/A	N/A	DWS Contrast?	N/A
N/A	Landing Slope (%)	N/A	N/A	DWS Length (in)	N/A
N/A	Landing X Slope (%)	N/A	N/A	DWS Full Width?	N/A
N/A	Landing Curb? (Y/N)	N/A	N/A	DWS Offset (in)	N/A
N/A	Shared Landing?	N/A			
N/A	Gutter Ponding?	N/A	N/A	Gutter Slope (%)	N/A
N/A	Gutter Lip Ht (in)	1.0	N/A	Gutter X Slope (%)	N/A
N/A	Painted X Walk1?	No	N/A	Painted X Walk2?	No
	X Walk 1 Direction	To SE		X Walk 2 Direction	To NE
N/A	X Walk 1 Width (in)	N/A	N/A	X Walk 2 Width (in)	N/A
	X Walk 1 Slope (%)	5.5		X Walk 2 Slope (%)	5.4
	X Walk 1 X Slope (%)	2.2		X Walk 2 X Slope (%)	4.1

N/A	Ramp inside XWalk1?	N/A	N/A	Ramp inside XWalk2?	N/A
	Road Slope (%)	5.2	N/A	Clear Space?	N/A
	Road X Slope (%)	4.7	N/A	Clear Space to XWalk (in)	N/A
N/A	Any Obstructions?	N/A	N/A	Storm Grate/Utility Hazard?	N/A
	Obstruction Type			Storm Grate/Utility Type	
		N/A			N/A
		Yes		Surface Condition? (G/P)	Good

Remove & Replace Curb Ramp With Two New Directional Ramps or Equivalent.
