## **Access Compliance Report Public Rights-of-Way** (Curb Ramps)

Intersection ID: 14235 Main Street: CAMDEN RD **Cross Street: E TREMONT AV** Location: Ε Ramp Type: BlendTrans1 Initial Pass/Fail: Fail **Overall Compliance: No** 25 ADA ID: F1D8790AAFE0 **Severity Score:**

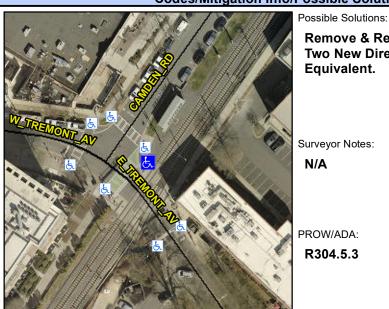
* .			,,
N/A	Flare Slope LT (%)	N/A	N/A	Flare Slope RT (%)
N/A	Flare Traversable LT?	N/A	N/A	Flare Traversable RT?
N/A	Landing Length (in)	N/A	N/A	DWS Provided?
N/A	Landing Width (in)	N/A	N/A	DWS Contrast?
N/A	Landing Slope (%)	N/A	N/A	DWS Length (in)
N/A	Landing X Slope (%)	N/A	N/A	DWS Full Width?
N/A	Landing Curb? (Y/N)	N/A	N/A	DWS Offset (in)
N/A	Shared Landing?	N/A		
N/A	Gutter Ponding?	N/A	N/A	Gutter Slope (%)
N/A	Gutter Lip Ht (in)	N/A	N/A	Gutter X Slope (%)
N/A	Painted X Walk1?	Yes	N/A	Painted X Walk2?
	X Walk 1 Direction	To SW		X Walk 2 Direction
	X Walk 1 Width (in)	144.0		X Walk 2 Width (in)
	X Walk 1 Slope (%)	7.4		X Walk 2 Slope (%)
	X Walk 1 X Slope (%)	2.4		X Walk 2 X Slope (%)
N/A	Ramp inside XWalk1?	Yes	N/A	Ramp inside XWalk2?
	Road Slope (%)	2.4		Clear Space?
	Road X Slope (%)	7.4	N/A	Clear Space to XWalk (in)
N/A	Any Obstructions?	N/A	N/A	Storm Grate/Utility Hazard?

Remove & Replace Curb Ramp With Two New Directional Ramps or Equivalent.

R304.5.3
