# Access Compliance Report

## Public Rights-of-Way

### (Curb Ramps)

Intersection ID: 52600	Main Street: MCCULLOUGH_DR	Cross Street: IKEA_BV	Location: NW
ADA ID: F1E12B8E6E87	Ramp Type: Perp	Initial Pass/Fail: Fail	Overall Compliance: No
Severity Score: 10			
Codes/Mitigation Info/Possible Solution		Field Measurements/Component Compliance

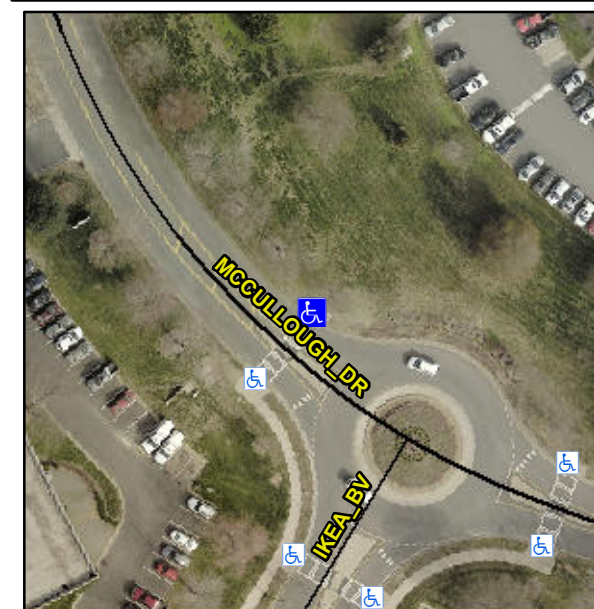
**Not Found, R304.5.1**

Compliance	Description	Data	Compliance	Description	Data
N/A	Ramp Length (in)	72.0	Yes	Ramp Slope (%)	7.2
No	Ramp Width (in)	47.5	Yes	Ramp XSlope (%)	2.2
N/A	Flare Type LT	N/A	N/A	Flare Type RT	N/A
N/A	Flare Slope LT (%)	N/A	N/A	Flare Slope RT (%)	N/A
N/A	Flare Traversable LT?	N/A	N/A	Flare Traversable RT?	N/A
N/A	Landing Length (in)	N/A	N/A	DWS Provided?	N/A
N/A	Landing Width (in)	N/A	N/A	DWS Contrast?	N/A
N/A	Landing Slope (%)	N/A	N/A	DWS Length (in)	N/A
N/A	Landing X Slope (%)	N/A	N/A	DWS Full Width?	N/A
N/A	Landing Curb? (Y/N)	N/A	N/A	DWS Offset (in)	N/A
N/A	Shared Landing?	N/A			
N/A	Gutter Ponding?	N/A	N/A	Gutter Slope (%)	N/A
N/A	Gutter Lip Ht (in)	N/A	N/A	Gutter X Slope (%)	N/A
N/A	Painted X Walk1?	Yes	N/A	Painted X Walk2?	N/A
	X Walk 1 Direction	To SW		X Walk 2 Direction	N/A
N/A	X Walk 1 Width (in)	111.0	N/A	X Walk 2 Width (in)	N/A
	X Walk 1 Slope (%)	1.5		X Walk 2 Slope (%)	N/A
	X Walk 1 X Slope (%)	4.1		X Walk 2 X Slope (%)	N/A

N/A	Ramp inside XWalk1?	Yes	N/A	Ramp inside XWalk2?	N/A
	Road Slope (%)	N/A	N/A	Clear Space?	N/A
	Road X Slope (%)	N/A	N/A	Clear Space to XWalk (in)	N/A
N/A	Any Obstructions?	N/A	N/A	Storm Grate/Utility Hazard?	N/A
	Obstruction Type			Storm Grate/Utility Type	
		N/A			N/A
			Yes	Surface Condition? (G/P)	Good

**Remove & Replace Entire Ramp.**

Total Cost: \$ 1850.00
