# Access Compliance Report

## Public Rights-of-Way

### (Curb Ramps)

Intersection ID: 17544	Main Street: MANHASSET_RD	Cross Street: MURRAYHILL_RD	Location: NW
ADA ID: F1F14EA0357F	Ramp Type: ParaDiag	Initial Pass/Fail: Fail	Overall Compliance: No
Codes/Mitigation Info/Possible Solution		Field Measurements/Component Compliance

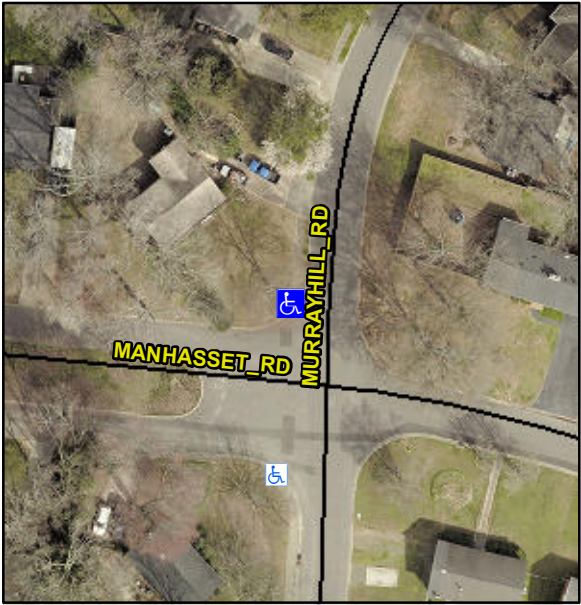
Compliance	Description	Data	Compliance	Description	Data
N/A	Ramp Length LT (in)	20.0	N/A	Ramp Length RT (in)	97.0
Yes	Ramp Width LT (in)	79.0	No	Ramp Width RT (in)	47.0
Yes	Ramp Slope LT (%)	4.4	No	Ramp Slope RT (%)	14.0
Yes	Ramp XSlope LT (%)	2.0	Yes	Ramp XSlope RT (%)	0.7
N/A	Landing Length (in)	N/A	N/A	DWS Provided?	N/A
N/A	Landing Width (in)	N/A	N/A	DWS Contrast?	N/A
N/A	Landing Slope (%)	N/A	N/A	DWS Length (in)	N/A
N/A	Landing X Slope (%)	N/A	N/A	DWS Full Width?	N/A
N/A	Landing Curb? (Y/N)	N/A	N/A	DWS Offset (in)	N/A
N/A	Shared Landing?	N/A			
N/A	Gutter Ponding?	N/A	N/A	Gutter Slope (%)	N/A
N/A	Gutter Lip Ht (in)	N/A	N/A	Gutter X Slope (%)	N/A
N/A	Painted X Walk1?	No	N/A	Painted X Walk2?	No
	X Walk 1 Direction	To S		X Walk 2 Direction	To E
N/A	X Walk 1 Width (in)	N/A	N/A	X Walk 2 Width (in)	N/A
	X Walk 1 Slope (%)	3.6		X Walk 2 Slope (%)	5.3
	X Walk 1 X Slope (%)	6.8		X Walk 2 X Slope (%)	4.5
N/A	Ramp inside XWalk1?	N/A	N/A	Ramp inside XWalk2?	N/A

Road Slope (%)	7.4	N/A	Clear Space?	N/A
	Road X Slope (%)	5.7	N/A	Clear Space to XWalk (in)	N/A
N/A	Any Obstructions?	N/A	N/A	Storm Grate/Utility Hazard?	N/A
	Obstruction Type			Storm Grate/Utility Type	
		N/A			N/A
			Yes	Surface Condition? (G/P)	Good
			N/A	Curb Slope (%)	N/A

Possible Solutions:			
	Remove & Replace Curb Ramp With Two New Directional Ramps or Equivalent.			
	Surveyor Notes:			
	LT RP < 5%			
	PROW/ADA:			
	R304.5.1, R304.3.2			
Street 1 Name	MANHASSET RD			
Stop Condition-Street 1	StopSign			
Street 2 Name	MURRAYHILL RD			
Stop Condition-Street 2	None			
Total Cost:		\$	3200.00
