# Access Compliance Report

## Public Rights-of-Way

### (Curb Ramps)

Intersection ID: 11979	Main Street: N_CALDWELL_ST	Cross Street: E_12TH_ST	Location: N
ADA ID: F21EB1A83D74	Ramp Type: Perp	Initial Pass/Fail: Fail	Overall Compliance: No
Severity Score: 13.75			
Codes/Mitigation Info/Possible Solution		Field Measurements/Component Compliance

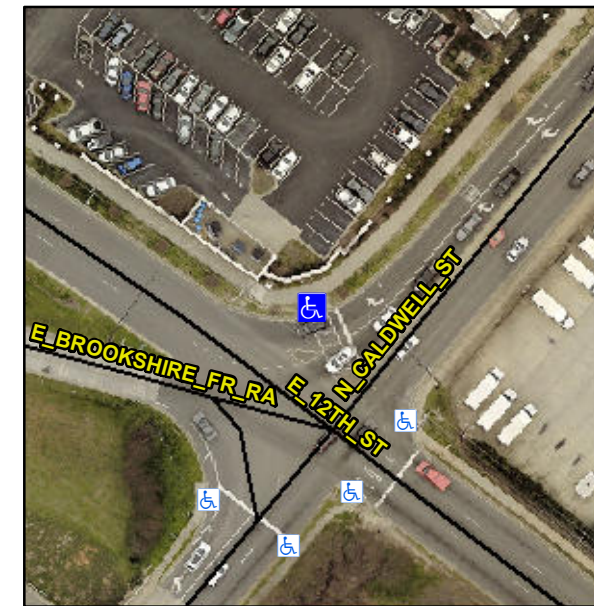
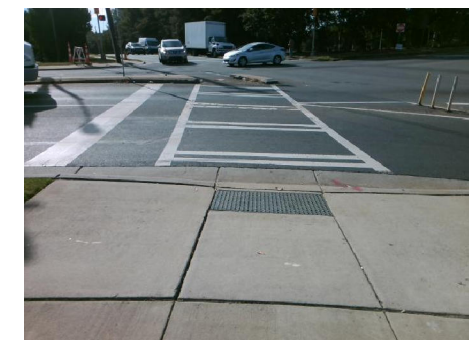
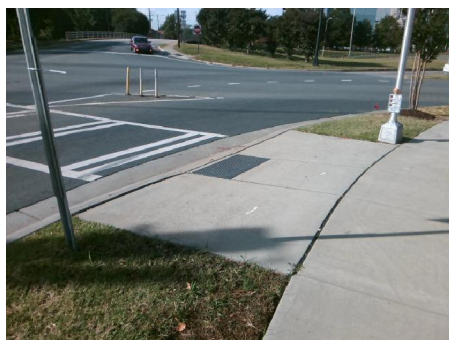
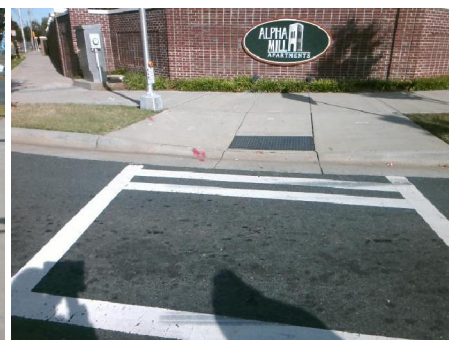
**Not Found, R304.2.2, R304.5.3**

Compliance	Description	Data	Compliance	Description	Data
N/A	Ramp Length (in)	84.5	No	Ramp Slope (%)	10.0
Yes	Ramp Width (in)	48.0	No	Ramp XSlope (%)	3.5
N/A	Flare Type LT	N/A	N/A	Flare Type RT	N/A
N/A	Flare Slope LT (%)	N/A	N/A	Flare Slope RT (%)	N/A
N/A	Flare Traversable LT?	N/A	N/A	Flare Traversable RT?	N/A
N/A	Landing Length (in)	N/A	N/A	DWS Provided?	N/A
N/A	Landing Width (in)	N/A	N/A	DWS Contrast?	N/A
N/A	Landing Slope (%)	N/A	N/A	DWS Length (in)	N/A
N/A	Landing X Slope (%)	N/A	N/A	DWS Full Width?	N/A
N/A	Landing Curb? (Y/N)	N/A	N/A	DWS Offset (in)	N/A
N/A	Shared Landing?	N/A			
N/A	Gutter Ponding?	N/A	N/A	Gutter Slope (%)	N/A
N/A	Gutter Lip Ht (in)	N/A	N/A	Gutter X Slope (%)	N/A
N/A	Painted X Walk1?	Yes	N/A	Painted X Walk2?	N/A
	X Walk 1 Direction	To SE		X Walk 2 Direction	N/A
N/A	X Walk 1 Width (in)	113.0	N/A	X Walk 2 Width (in)	N/A
	X Walk 1 Slope (%)	2.0		X Walk 2 Slope (%)	N/A
	X Walk 1 X Slope (%)	2.4		X Walk 2 X Slope (%)	N/A

N/A	Ramp inside XWalk1?	Yes	N/A	Ramp inside XWalk2?	N/A
	Road Slope (%)	N/A	N/A	Clear Space?	N/A
	Road X Slope (%)	N/A	N/A	Clear Space to XWalk (in)	N/A
N/A	Any Obstructions?	N/A	N/A	Storm Grate/Utility Hazard?	N/A
	Obstruction Type			Storm Grate/Utility Type	
		N/A			N/A
		Yes		Surface Condition? (G/P)	Good

**Remove & Replace Entire Ramp.**

Total Cost: \$ 1850.00
