Access Compliance Report

Public Rights-of-Way

(Curb Ramps)

Intersection ID: 10031827	Main Street: MILLWRIGHT_LN	Cross Street: N/A	Location: SW
ADA ID: F228A5DE8FC9	Ramp Type: Perp	Initial Pass/Fail: Fail	Overall Compliance: No
			Severity Score: 33.75

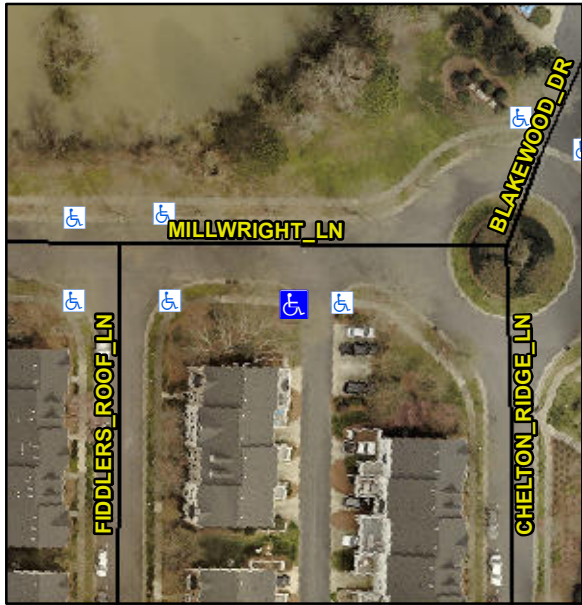
Possible Solutions:		Compliance	Description	Data	Compliance	Description	Data
	Remove & Replace Entire Ramp.		N/A	Ramp Length (in)	59.0	No	Ramp Slope (%)	9.5
			No	Ramp Width (in)	41.0	No	Ramp XSlope (%)	6.2
			N/A	Flare Type LT	N/A	N/A	Flare Type RT	N/A
			N/A	Flare Slope LT (%)	N/A	N/A	Flare Slope RT (%)	N/A
			N/A	Flare Traversable LT?	N/A	N/A	Flare Traversable RT?	N/A
			N/A	Landing Length (in)	N/A	N/A	DWS Provided?	N/A
			N/A	Landing Width (in)	N/A	N/A	DWS Contrast?	N/A
			N/A	Landing Slope (%)	N/A	N/A	DWS Length (in)	N/A
			N/A	Landing X Slope (%)	N/A	N/A	DWS Full Width?	N/A
Surveyor Notes:	N/A		N/A	Landing Curb? (Y/N)	N/A	N/A	DWS Offset (in)	N/A
			N/A	Shared Landing?	N/A			
	PROW/ADA:		N/A	Gutter Ponding?	N/A	N/A	Gutter Slope (%)	N/A
	Not Found, R304.5.1, R304.2.2, R304.5.3		N/A	Gutter Lip Ht (in)	N/A	N/A	Gutter X Slope (%)	N/A

N/A	Painted X Walk1?	No	N/A	Painted X Walk2?	N/A
				X Walk 1 Direction	To E		X Walk 2 Direction	N/A
			N/A	X Walk 1 Width (in)	N/A	N/A	X Walk 2 Width (in)	N/A
				X Walk 1 Slope (%)	2.2		X Walk 2 Slope (%)	N/A
				X Walk 1 X Slope (%)	1.7		X Walk 2 X Slope (%)	N/A
			N/A	Ramp inside XWalk1?	N/A	N/A	Ramp inside XWalk2?	N/A
			Road Slope (%)	N/A	N/A	Clear Space?	N/A	
			Road X Slope (%)	N/A	N/A	Clear Space to XWalk (in)	N/A	
		N/A	Any Obstructions?	N/A	N/A	Storm Grate/Utility Hazard?	N/A	
			Obstruction Type			Storm Grate/Utility Type		
				N/A			N/A	
					Yes	Surface Condition? (G/P)	Good

Total Cost: \$ 1850.00
