Access Compliance Report

Public Rights-of-Way

(Curb Ramps)

Intersection ID: 3064	Main Street: BLACK_MAPLE_AV	Cross Street: HEDGE_MAPLE_RD	Location: W
ADA ID: F22C66317317	Ramp Type: Perp	Initial Pass/Fail: Fail	Overall Compliance: No
			Severity Score: 10

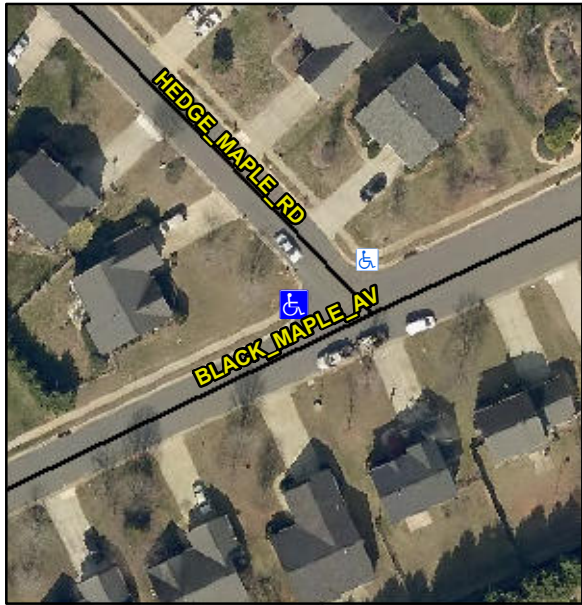
Possible Solutions:		Compliance	Description	Data	Compliance	Description	Data
	Remove & Replace Entire Ramp.		N/A	Ramp Length (in)	96.5	Yes	Ramp Slope (%)	7.4
			No	Ramp Width (in)	44.0	No	Ramp XSlope (%)	2.4
			N/A	Flare Type LT	N/A	N/A	Flare Type RT	N/A
			N/A	Flare Slope LT (%)	N/A	N/A	Flare Slope RT (%)	N/A
			N/A	Flare Traversable LT?	N/A	N/A	Flare Traversable RT?	N/A
			N/A	Landing Length (in)	N/A	N/A	DWS Provided?	N/A
			N/A	Landing Width (in)	N/A	N/A	DWS Contrast?	N/A
			N/A	Landing Slope (%)	N/A	N/A	DWS Length (in)	N/A
			N/A	Landing X Slope (%)	N/A	N/A	DWS Full Width?	N/A
Surveyor Notes:		N/A	N/A	Landing Curb? (Y/N)	N/A	N/A	DWS Offset (in)	N/A
PROW/ADA:		R304.5.1, R304.5.3	N/A	Shared Landing?	N/A			
			N/A	Gutter Ponding?	N/A	N/A	Gutter Slope (%)	N/A
			N/A	Gutter Lip Ht (in)	N/A	N/A	Gutter X Slope (%)	N/A

N/A	Painted X Walk1?	No	N/A	Painted X Walk2?	N/A
				X Walk 1 Direction	To NE		X Walk 2 Direction	N/A
			N/A	X Walk 1 Width (in)	N/A	N/A	X Walk 2 Width (in)	N/A
				X Walk 1 Slope (%)	3.7		X Walk 2 Slope (%)	N/A
				X Walk 1 X Slope (%)	0.6		X Walk 2 X Slope (%)	N/A
			N/A	Ramp inside XWalk1?	N/A	N/A	Ramp inside XWalk2?	N/A
				Road Slope (%)	N/A	N/A	Clear Space?	N/A
				Road X Slope (%)	N/A	N/A	Clear Space to XWalk (in)	N/A
			N/A	Any Obstructions?	N/A	N/A	Storm Grate/Utility Hazard?	N/A
				Obstruction Type			Storm Grate/Utility Type	
					N/A			N/A
						Yes	Surface Condition? (G/P)	Good
