Access Compliance Report

Public Rights-of-Way

(Curb Ramps)

Intersection ID: 7636	Main Street: GEORGETOWN_DR	Cross Street: ROSADA_AV	Location:	N
ADA ID: F23AF0830E70	Ramp Type: Perp	Initial Pass/Fail: Fail	Overall Compliance: No	Severity Score: 21.25

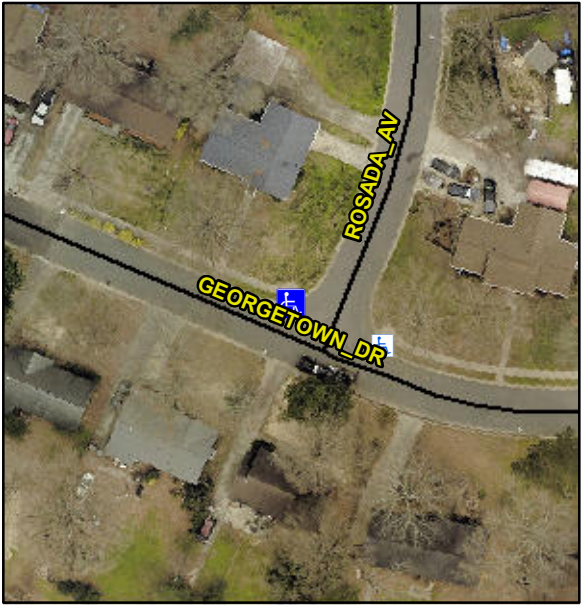
Possible Solutions:		Compliance	Description	Data
	Remove & Replace Entire Ramp.		No	Ramp Length (in)	52.0
			No	Ramp Width (in)	37.0
			N/A	Flare Type LT	N/A
			N/A	Flare Slope LT (%)	N/A
			N/A	Flare Traversable LT?	N/A
			N/A	Landing Length (in)	N/A
			N/A	Landing Width (in)	N/A
			N/A	Landing Slope (%)	N/A
			N/A	Landing X Slope (%)	N/A
<p>Surveyor Notes:</p> <p>N/A</p> <p>PROW/ADA:</p> <p>Not Found, R304.5.1, R304.2.2</p>			N/A	Flare Type RT	N/A
			N/A	Flare Slope RT (%)	N/A
			N/A	Flare Traversable RT?	N/A
			N/A	DWS Provided?	N/A
			N/A	DWS Contrast?	N/A
			N/A	DWS Length (in)	N/A
			N/A	DWS Full Width?	N/A
			N/A	DWS Offset (in)	N/A
			N/A	Gutter Ponding?	N/A
			N/A	Gutter Lip Ht (in)	N/A
			No	Painted X Walk1?	N/A
				X Walk 1 Direction	To SE
			N/A	X Walk 1 Width (in)	N/A
				X Walk 1 Slope (%)	1.3
				X Walk 1 X Slope (%)	3.2

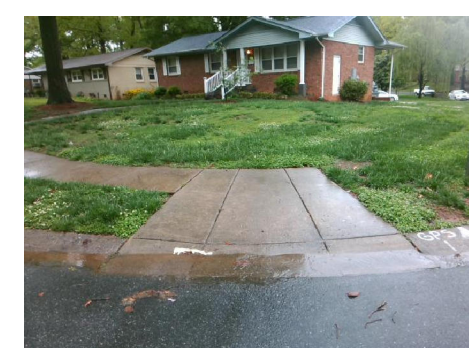
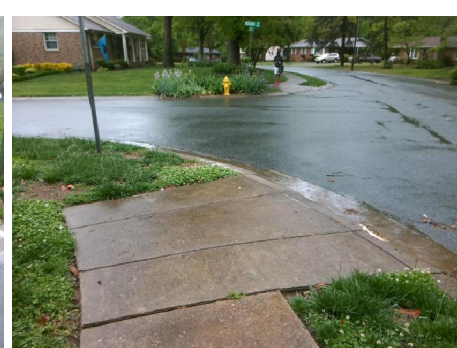
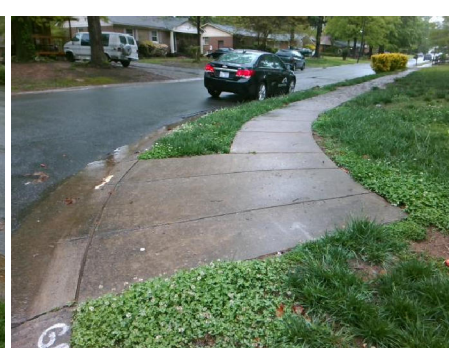
N/A	Ramp inside XWalk1?	N/A
			N/A	Road Slope (%)	N/A
			N/A	Road X Slope (%)	N/A
			N/A	Any Obstructions?	N/A
				Obstruction Type	
Total Cost:		\$ 1850.00	N/A	Storm Grate/Utility Hazard?	N/A
			N/A	Storm Grate/Utility Type	N/A
			Yes	Surface Condition? (G/P)	Good
