# Access Compliance Report

## Public Rights-of-Way

### (Curb Ramps)

Intersection ID: 14659	Main Street: E_WORTHINGTON_AV	Cross Street: SPRINGDALE_AV	Location: E
ADA ID: F2463C026AFB	Ramp Type: Perp	Initial Pass/Fail: Fail	Overall Compliance: No
Severity Score: 12.5			
Codes/Mitigation Info/Possible Solution		Field Measurements/Component Compliance

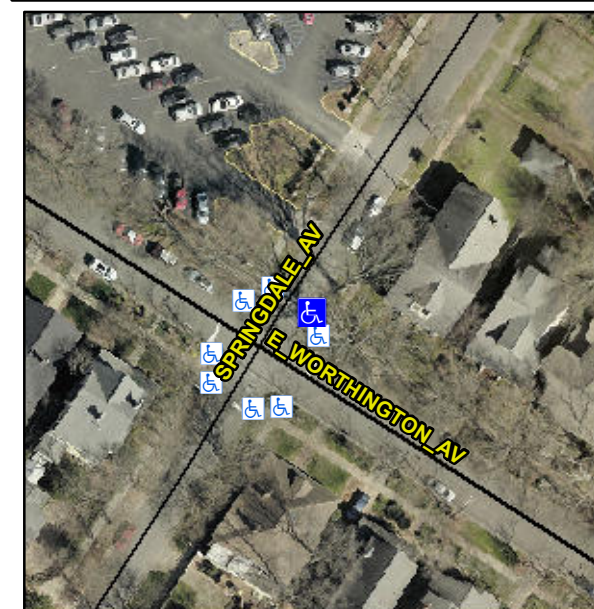
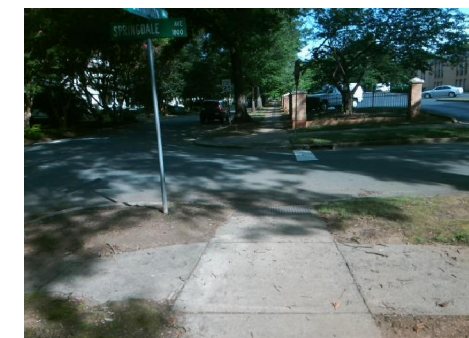
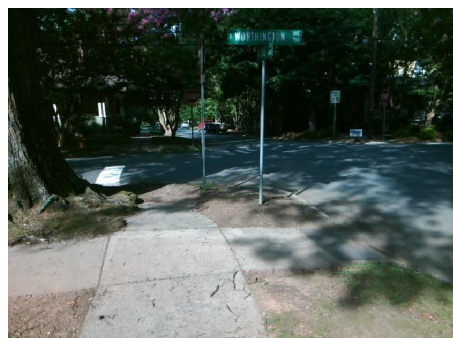
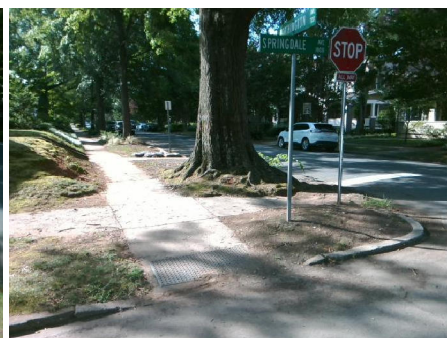
Compliance	Description	Data	Compliance	Description	Data
N/A	Ramp Length (in)	78.0	No	Ramp Slope (%)	8.4
Yes	Ramp Width (in)	59.0	Yes	Ramp XSlope (%)	2.0
N/A	Flare Type LT	N/A	N/A	Flare Type RT	N/A
N/A	Flare Slope LT (%)	N/A	N/A	Flare Slope RT (%)	N/A
N/A	Flare Traversable LT?	N/A	N/A	Flare Traversable RT?	N/A
N/A	Landing Length (in)	N/A	N/A	DWS Provided?	N/A
N/A	Landing Width (in)	N/A	N/A	DWS Contrast?	N/A
N/A	Landing Slope (%)	N/A	N/A	DWS Length (in)	N/A
N/A	Landing X Slope (%)	N/A	N/A	DWS Full Width?	N/A
N/A	Landing Curb? (Y/N)	N/A	N/A	DWS Offset (in)	N/A
N/A	Shared Landing?	N/A			
N/A	Gutter Ponding?	Yes	N/A	Gutter Slope (%)	N/A
N/A	Gutter Lip Ht (in)	N/A	N/A	Gutter X Slope (%)	N/A
N/A	Painted X Walk1?	No	N/A	Painted X Walk2?	N/A
	X Walk 1 Direction	To NW		X Walk 2 Direction	N/A
N/A	X Walk 1 Width (in)	N/A	N/A	X Walk 2 Width (in)	N/A
	X Walk 1 Slope (%)	3.0		X Walk 2 Slope (%)	N/A
	X Walk 1 X Slope (%)	1.0		X Walk 2 X Slope (%)	N/A

N/A	Ramp inside XWalk1?	N/A	N/A	Ramp inside XWalk2?	N/A
	Road Slope (%)	N/A	N/A	Clear Space?	N/A
	Road X Slope (%)	N/A	N/A	Clear Space to XWalk (in)	N/A
N/A	Any Obstructions?	N/A	N/A	Storm Grate/Utility Hazard?	N/A
	Obstruction Type			Storm Grate/Utility Type	
		N/A			N/A
		Yes		Surface Condition? (G/P)	Good

Possible Solutions:

**Remove & Replace Entire Ramp.**

**R304.2.2**

**\$ 1850.00**
