## **Access Compliance Report Public Rights-of-Way** (Curb Ramps)

Intersection ID: 50441 Main Street: ALICE MCGINN DR **Cross Street: COPPER MOUNTAIN BV** Location: SE **ADA ID: F25ABA1A818E** Ramp Type: PerpDiag Initial Pass/Fail: Fail **Overall Compliance: No** Severity Score: 13.75

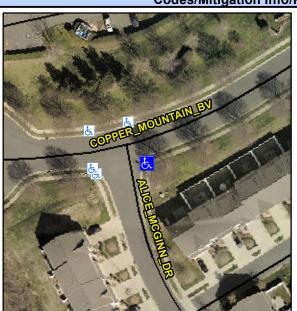
Field Measurements/Component Compliance						
Compliance Description		Data	Comp	liance	Description	Data
N/A	Ramp Length (in)	44.0	No	Ramp	Slope (%)	8.4
Yes	Ramp Width (in)	48.0	No	Ramp	XSlope (%)	2.8
N/A	Flare Type LT	N/A	N/A	Flare	Type RT	N/A
N/A	Flare Slope LT (%)	N/A	N/A	Flare	Slope RT (%)	N/A
N/A	Flare Traversable LT?	N/A	N/A	Flare	Traversable RT?	N/A
N/A	Landing Length (in)	N/A	N/A	DWS	Provided?	N/A
N/A	Landing Width (in)	N/A	N/A	DWS	Contrast?	N/A
N/A	Landing Slope (%)	N/A	N/A	DWS	Length (in)	N/A
N/A	Landing X Slope (%)	N/A	N/A	DWS	Full Width?	N/A
N/A	Landing Curb? (Y/N)	N/A	N/A	DWS	Offset (in)	N/A
N/A	Shared Landing?	N/A				
N/A	Gutter Ponding?	N/A	N/A	Gutte	r Slope (%)	N/A
N/A	Gutter Lip Ht (in)	N/A	N/A	Gutte	r X Slope (%)	N/A
N/A	Painted X Walk1?	No	N/A	Painte	ed X Walk2?	No
	X Walk 1 Direction	To N		X Wal	lk 2 Direction	To W
N/A	X Walk 1 Width (in)	N/A	N/A	X Wal	lk 2 Width (in)	N/A
	X Walk 1 Slope (%)	3.8		X Wal	lk 2 Slope (%)	4.1

X Walk 1 X Slope (%)	2.7		X Wal	lk 2 X Slope (%)	0.2
N/A	Ramp inside XWalk1?	N/A	N/A	Ramp	inside XWalk2?	N/A
	Road Slope (%)	3.1	N/A	Clear	Space?	N/A
	Road X Slope (%)	3.2	N/A	Clear	Space to XWalk (in)	N/A
N/A	Any Obstructions?	N/A	N/A	Storm	Grate/Utility Hazard?	N/A
	Obstruction Type			Storm	Grate/Utility Type	
		N/A				N/A
			Yes	Surfac	ce Condition? (G/P)	Good
	717

Possible Solutions: **Remove & Replace Curb Ramp With Two New Directional Ramps or** Equivalent. Surveyor Notes: N/A PROW/ADA: Not Found, R304.2.2, R304.5.3
