Access Compliance Report Public Rights-of-Way (Curb Ramps)

Intersection ID: 12672	Main Street: E_W_T_HARRIS_BV			treet:	KEYWAY_BV	Location:	NW		
ADA ID: F25B6B37AB3A	Ramp Ty	Ramp Type: PerpDiag			ail: Fail Overall C	o Severity Score:	13.75		
Codes/Mitigation Info/Possible Solution				Field Measurements/Component Compliance					
Restances in the second se	and a state	Possible Solutions:		Compliance Description		Data Compliance Description			Data
a		Remove & Replace Curb Ramp W	lith	N/A	Ramp Length (in)	60.0	No	Ramp Slope (%)	8.8
		Two New Directional Ramps or		Yes	Ramp Width (in)	49.0	No	Ramp XSlope (%)	4.2
		Equivalent.		N/A	Flare Type LT	N/A	N/A	Flare Type RT	N/A
				N/A	Flare Slope LT (%)	N/A	N/A	Flare Slope RT (%)	N/A
TELETIL.	10 10			N/A	Flare Traversable LT?	N/A	N/A	Flare Traversable RT?	N/A
				N/A	Landing Length (in)	N/A	N/A	DWS Provided?	N/A
A CONTRACTOR		Surveyor Notes:		N/A	Landing Width (in)	N/A	N/A	DWS Contrast?	N/A
de la constante de		N/A		N/A	Landing Slope (%)	N/A	N/A	DWS Length (in)	N/A

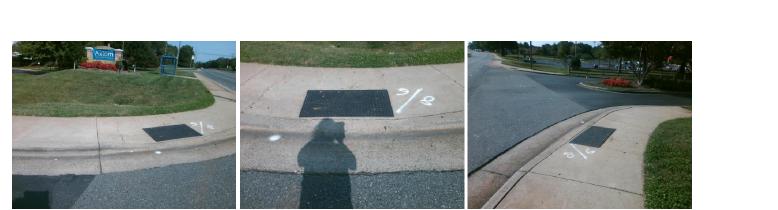
5. L	PROW/ADA:		N/A	Gutter Ponding?	N/A	N/A	Gutter Slope (%)	N/A
		Not Found, R304.2.2, R304.5.3		N/A	Gutter Lip Ht (in)	N/A	N/A	Gutter X Slope (%)	N/A
		,,,,,,,,		N/A	Painted X Walk1?	No	N/A	Painted X Walk2?	No
					X Walk 1 Direction	To S		X Walk 2 Direction	To E
2 3				N/A	X Walk 1 Width (in)	N/A	N/A	X Walk 2 Width (in)	N/A
Street 1 Name	KEYWAY BV	-			X Walk 1 Slope (%)	0.3		X Walk 2 Slope (%)	2.4
Stop Condition-Street 2	None				X Walk 1 X Slope (%)	3.5		X Walk 2 X Slope (%)	1.4
Street 2 Name	E W T HARRIS BV			N/A	Ramp inside XWalk1?	N/A	N/A	Ramp inside XWalk2?	N/A
Stop Condition-Street 1	None				Road Slope (%)	3.4	N/A	Clear Space?	N/A
					Road X Slope (%)	2.2	N/A	Clear Space to XWalk (in)	N/A
				N/A	Any Obstructions?	N/A	N/A	Storm Grate/Utility Hazard?	N/A
		Total Cost: \$ 32	200.00		Obstruction Type			Storm Grate/Utility Type	
						N/A			N/A
