# Access Compliance Report

## Public Rights-of-Way

### (Curb Ramps)

Intersection ID: 10074	Main Street: KILDARE_DR	Cross Street: OLINDA_ST	Location: W
ADA ID: F263B0AC1C9F	Ramp Type: Perp	Initial Pass/Fail: Fail	Overall Compliance: No
Severity Score: 12.5			
Codes/Mitigation Info/Possible Solution		Field Measurements/Component Compliance

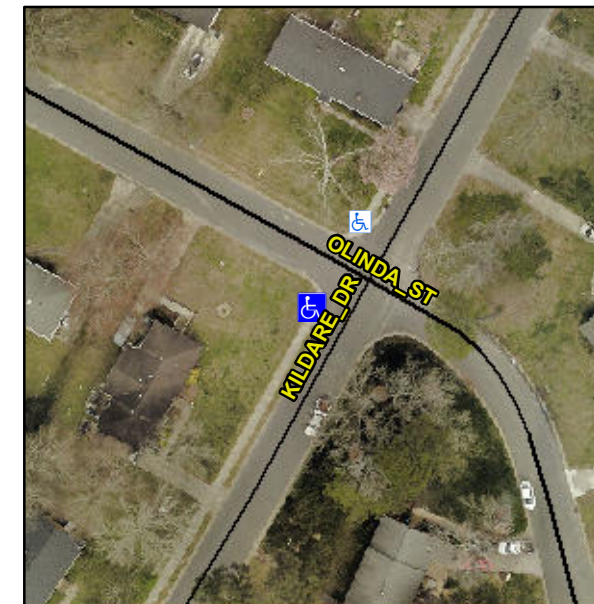
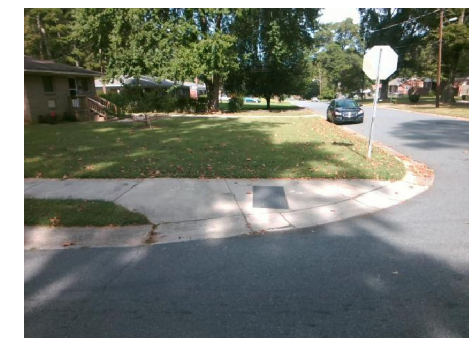
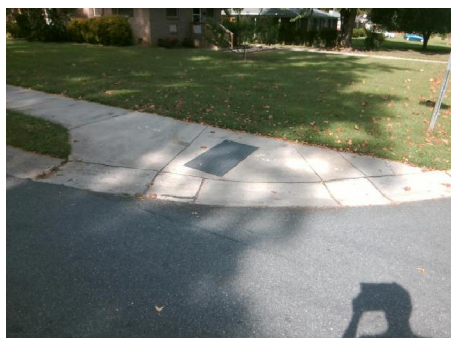
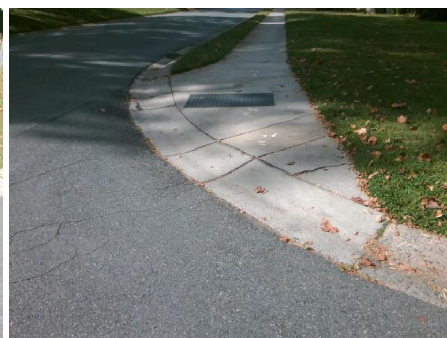
**Not Found, R304.5.3**

Compliance	Description	Data	Compliance	Description	Data
N/A	Ramp Length (in)	94.0	Yes	Ramp Slope (%)	6.6
Yes	Ramp Width (in)	60.0	No	Ramp XSlope (%)	5.2
N/A	Flare Type LT	N/A	N/A	Flare Type RT	N/A
N/A	Flare Slope LT (%)	N/A	N/A	Flare Slope RT (%)	N/A
N/A	Flare Traversable LT?	N/A	N/A	Flare Traversable RT?	N/A
N/A	Landing Length (in)	N/A	N/A	DWS Provided?	N/A
N/A	Landing Width (in)	N/A	N/A	DWS Contrast?	N/A
N/A	Landing Slope (%)	N/A	N/A	DWS Length (in)	N/A
N/A	Landing X Slope (%)	N/A	N/A	DWS Full Width?	N/A
N/A	Landing Curb? (Y/N)	N/A	N/A	DWS Offset (in)	N/A
N/A	Shared Landing?	N/A			
N/A	Gutter Ponding?	N/A	N/A	Gutter Slope (%)	N/A
N/A	Gutter Lip Ht (in)	0.8	N/A	Gutter X Slope (%)	N/A
N/A	Painted X Walk1?	No	N/A	Painted X Walk2?	N/A
	X Walk 1 Direction	To NE		X Walk 2 Direction	N/A
N/A	X Walk 1 Width (in)	N/A	N/A	X Walk 2 Width (in)	N/A
	X Walk 1 Slope (%)	3.1		X Walk 2 Slope (%)	N/A
	X Walk 1 X Slope (%)	3.6		X Walk 2 X Slope (%)	N/A

N/A	Ramp inside XWalk1?	N/A	N/A	Ramp inside XWalk2?	N/A
	Road Slope (%)	N/A	N/A	Clear Space?	N/A
	Road X Slope (%)	N/A	N/A	Clear Space to XWalk (in)	N/A
N/A	Any Obstructions?	N/A	N/A	Storm Grate/Utility Hazard?	N/A
	Obstruction Type			Storm Grate/Utility Type	
		N/A			N/A
			Yes	Surface Condition? (G/P)	Good

**Remove & Replace Entire Ramp.**

Total Cost: \$ 1850.00
