# Access Compliance Report

## Public Rights-of-Way

### (Curb Ramps)

Intersection ID: 3040		Main Street: FOX_GLEN_RD		Cross Street: RED_TAIL_CT		Location: SE											
ADA ID: F26581E0DA5D		Ramp Type: Directional1		Initial Pass/Fail: Fail		Overall Compliance: No		Severity Score: 13.75									
Codes/Mitigation Info/Possible Solution				Field Measurements/Component Compliance

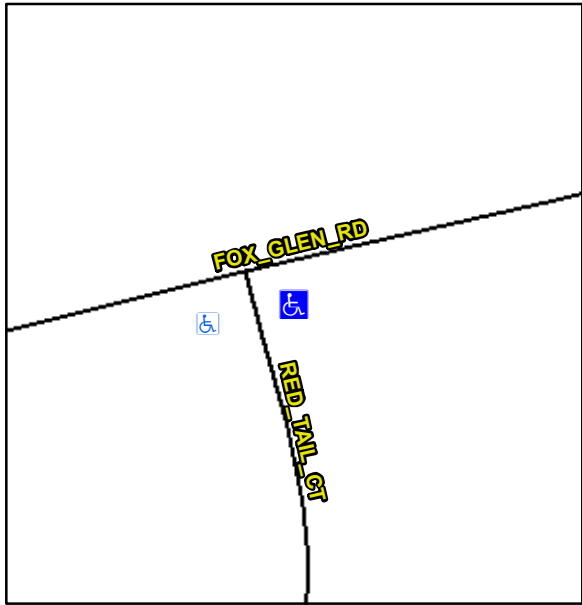
Possible Solutions:		Compliance		Description		Data		Compliance		Description		Data	
				Remove & Replace Entire Ramp.		N/A		Ramp Length (in)		22.0		N/A		Grade Break?		N/A	
Surveyor Notes:				N/A		Yes		Ramp Width (in)		56.0		N/A		Grade Break Slope (%)		0.0	
						No		Ramp Slope (%)		10.7		N/A		Grade Break XSlope (%)		0.0	
PROW/ADA:				R304.2.2, R304.5.3		No		Ramp XSlope (%)		4.8							
						N/A		Flare Type LT		N/A		N/A		Flare Type RT		N/A	
Street 1 Name				RED TAIL CT		N/A		Flare Slope LT (%)		N/A		N/A		Flare Slope RT (%)		0.0	
				StopSign		N/A		Flare Traversable LT?		N/A		N/A		Flare Traversable RT?		N/A
