Access Compliance Report Public Rights-of-Way (Curb Ramps)

Intersection ID: 43967 Main Street: BEAM RD Cross Street: CARRINGTON OAKS DR Location: NW **Severity Score: ADA ID: F26A3F7D1DEA** Ramp Type: PerpDiag Initial Pass/Fail: Fail **Overall Compliance: No** 12.5

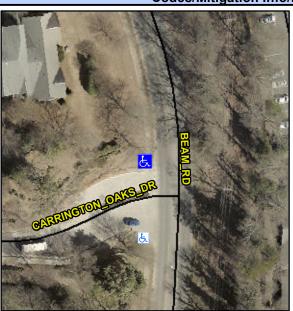
Yes Ramp XSlope (%) Ramp Width (in) 48.0 N/A Flare Type LT N/A Flare Type RT N/A N/A Flare Slope RT (%) Flare Slope LT (%) Flare Traversable LT? N/A N/A Flare Traversable RT? N/A N/A **DWS Provided?** Landing Length (in) Landing Width (in) N/A N/A **DWS Contrast?** N/A Landing Slope (%) N/A DWS Length (in) Landing X Slope (%) N/A N/A DWS Full Width? Landing Curb? (Y/N) N/A N/A DWS Offset (in) N/A Shared Landing? **Gutter Ponding?** N/A N/A Gutter Slope (%) Gutter Lip Ht (in) N/A N/A Gutter X Slope (%) Painted X Walk1? No N/A Painted X Walk2? X Walk 1 Direction To S X Walk 2 Direction N/A X Walk 1 Width (in) X Walk 2 Width (in) X Walk 1 Slope (%) 5.2 X Walk 2 Slope (%) X Walk 2 X Slope (%) X Walk 1 X Slope (%) 3.6 N/A N/A Ramp inside XWalk2? Ramp inside XWalk1? Road Slope (%) 0.6 N/A Clear Space? N/A Road X Slope (%) 4.8 Clear Space to XWalk (in) N/A N/A Any Obstructions? Storm Grate/Utility Hazard?

CARRINGTON OAKS DR Street 1 Name Stop Condition-Street 2 StopSign **BEAM RD** Street 2 Name Stop Condition-Street 1 None Possible Solutions: Compliance Description Remove & Replace Curb Ramp With Two New Directional Ramps or Equivalent. Surveyor Notes: N/A PROW/ADA: Not Found, R304.2.2
