Good

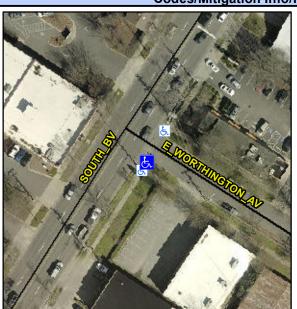
Intersection ID: 14203 Main Street: E WORTHINGTON AV **Cross Street: SOUTH BV** Location: S

E WORTHINGTON AV Street 1 Name Stop Condition-Street 2 StopSign N/A Street 2 Name Stop Condition-Street 1 N/A Possible Solutions: Remove & Replace Entire Ramp. Surveyor Notes: N/A PROW/ADA: Not Found, R304.5.1, R304.5.3
