# Access Compliance Report

## Public Rights-of-Way

### (Curb Ramps)

Intersection ID: 13518	Main Street: COMMONWEALTH_AV	Cross Street: ST_JULIEN_ST	Location: S
ADA ID: F27239969854	Ramp Type: Perp	Initial Pass/Fail: Pass	Overall Compliance: No
Codes/Mitigation Info/Possible Solution		Field Measurements/Component Compliance	
Severity Score: 7.5

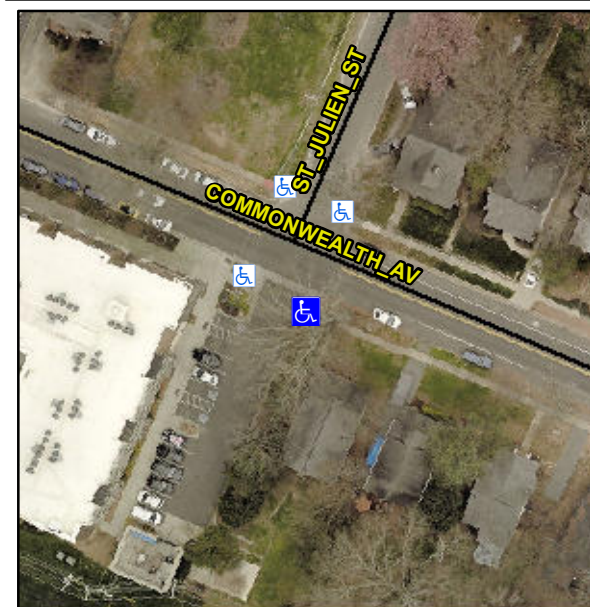
**Not Found, R304.2.1, R304.2.2-Perp,  
R304.3.2-Para, R305.1.4, R305.2,  
R304.5.4, R304.5.3**

Compliance	Description	Data	Compliance	Description	Data
N/A	Ramp Length (in)	62.0	Yes	Ramp Slope (%)	6.6
Yes	Ramp Width (in)	48.0	Yes	Ramp XSlope (%)	1.3
N/A	Flare Type LT	Sloped	N/A	Flare Type RT	N/A
N/A	Flare Slope LT (%)	9.0	N/A	Flare Slope RT (%)	11.4
N/A	Flare Traversable LT?	No	N/A	Flare Traversable RT?	No
No	Landing Length (in)	44.0	Yes	DWS Provided?	Yes
Yes	Landing Width (in)	48.0	Yes	DWS Contrast?	Yes
No	Landing Slope (%)	2.1	Yes	DWS Length (in)	24.0
Yes	Landing X Slope (%)	0.8	No	DWS Full Width?	No
N/A	Landing Curb? (Y/N)	No	No	DWS Offset (in)	5.5
N/A	Shared Landing?	No			
Yes	Gutter Ponding?	No	No	Gutter Slope (%)	5.6
Yes	Gutter Lip Ht (in)	0.0	No	Gutter X Slope (%)	3.8
N/A	Painted X Walk1?	No	N/A	Painted X Walk2?	N/A
	X Walk 1 Direction	To NW		X Walk 2 Direction	N/A
N/A	X Walk 1 Width (in)	N/A	N/A	X Walk 2 Width (in)	N/A
	X Walk 1 Slope (%)	3.4		X Walk 2 Slope (%)	N/A
	X Walk 1 X Slope (%)	2.6		X Walk 2 X Slope (%)	N/A

N/A	Ramp inside XWalk1?	N/A	N/A	Ramp inside XWalk2?	N/A
	Road Slope (%)	N/A	N/A	Clear Space?	Yes
	Road X Slope (%)	N/A	N/A	Clear Space to XWalk (in)	N/A
Yes	Any Obstructions?	No	Yes	Storm Grate/Utility Hazard?	No
	Obstruction Type			Storm Grate/Utility Type	
		N/A			N/A
			Yes	Surface Condition? (G/P)	Good

**Remove & Replace Entire Ramp.  
Remove & Replace Gutter.**
