# Access Compliance Report

## Public Rights-of-Way

### (Curb Ramps)

Intersection ID: N/A	Main Street: E_4TH_ST	Cross Street: N/A	Location: SW
ADA ID: F27524D8D14D	Ramp Type: Perp	Initial Pass/Fail: Fail	Overall Compliance: No
Severity Score: 12.5			
Codes/Mitigation Info/Possible Solution		Field Measurements/Component Compliance

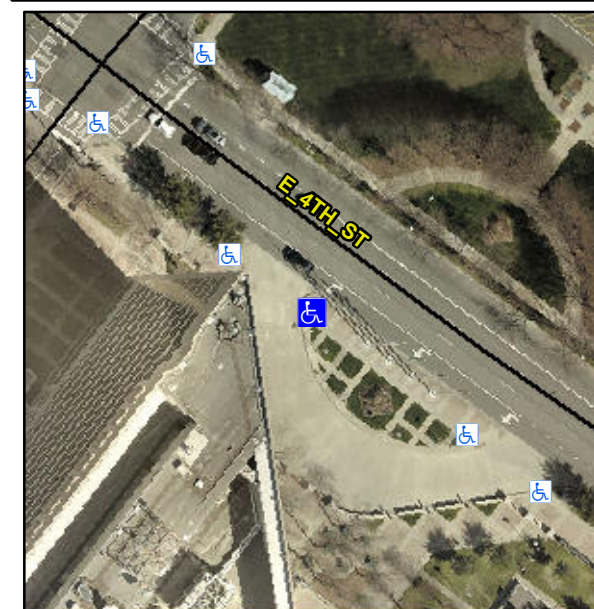
Compliance	Description	Data	Compliance	Description	Data
N/A	Ramp Length (in)	81.0	No	Ramp Slope (%)	11.4
Yes	Ramp Width (in)	72.0	Yes	Ramp XSlope (%)	1.1
N/A	Flare Type LT	N/A	N/A	Flare Type RT	N/A
N/A	Flare Slope LT (%)	N/A	N/A	Flare Slope RT (%)	N/A
N/A	Flare Traversable LT?	No	N/A	Flare Traversable RT?	No
N/A	Landing Length (in)	N/A	N/A	DWS Provided?	N/A
N/A	Landing Width (in)	N/A	N/A	DWS Contrast?	N/A
N/A	Landing Slope (%)	N/A	N/A	DWS Length (in)	N/A
N/A	Landing X Slope (%)	N/A	N/A	DWS Full Width?	N/A
N/A	Landing Curb? (Y/N)	N/A	N/A	DWS Offset (in)	N/A
N/A	Shared Landing?	N/A			
N/A	Gutter Ponding?	N/A	N/A	Gutter Slope (%)	N/A
N/A	Gutter Lip Ht (in)	N/A	N/A	Gutter X Slope (%)	N/A
N/A	Painted X Walk1?	No	N/A	Painted X Walk2?	N/A
	X Walk 1 Direction	To NW		X Walk 2 Direction	N/A
N/A	X Walk 1 Width (in)	N/A	N/A	X Walk 2 Width (in)	N/A
	X Walk 1 Slope (%)	0.1		X Walk 2 Slope (%)	N/A
	X Walk 1 X Slope (%)	0.2		X Walk 2 X Slope (%)	N/A

N/A	Ramp inside XWalk1?	N/A	N/A	Ramp inside XWalk2?	N/A
	Road Slope (%)	N/A	N/A	Clear Space?	N/A
	Road X Slope (%)	N/A	N/A	Clear Space to XWalk (in)	N/A
N/A	Any Obstructions?	N/A	N/A	Storm Grate/Utility Hazard?	N/A
	Obstruction Type			Storm Grate/Utility Type	
		N/A			N/A
			Yes	Surface Condition? (G/P)	Good

Possible Solutions:

**Remove & Replace Entire Ramp.**

**R304.2.2**
