# Access Compliance Report

## Public Rights-of-Way

### (Curb Ramps)

Intersection ID: 13579	Main Street: S_MCDOWELL_ST	Cross Street: E_STONEWALL_ST	Location: NE
ADA ID: F2A9A317A63B	Ramp Type: Combination1	Initial Pass/Fail: Pass	Overall Compliance: No
			Severity Score: 10.25

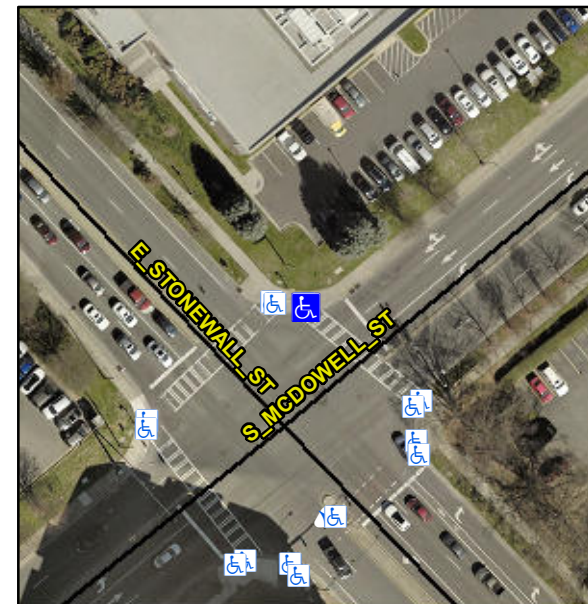
**RT RP < 5%**

**Not Found, R304.5.3, R304.2.1,  
R304.2.2-Perp, R304.3.2-Para**

Compliance	Description	Data	Compliance	Description	Data
N/A	Ramp Length LT (in)	53.0	N/A	Ramp Length RT (in)	52.0
Yes	Ramp Width LT (in)	60.0	Yes	Ramp Width RT (in)	93.0
Yes	Ramp Slope LT (%)	6.2	Yes	Ramp Slope RT (%)	1.0
No	Ramp XSlope LT (%)	3.2	No	Ramp XSlope RT (%)	3.5
N/A	Ramp Length (in)	108.0	Yes	Ramp Slope (%)	5.4
Yes	Ramp Width (in)	49.0	No	Ramp XSlope (%)	3.7
N/A	Flare Type LT	Sloped	N/A	Flare Type RT	Sloped
Yes	Flare Slope LT (%)	8.4	Yes	Flare Slope RT (%)	3.5
N/A	Flare Traversable LT?	Yes	N/A	Flare Traversable RT?	Yes
No	Landing Length (in)	N/A	Yes	DWS Provided?	Yes
No	Landing Width (in)	N/A	Yes	DWS Contrast?	Yes
No	Landing Slope (%)	N/A	Yes	DWS Length (in)	25.0
No	Landing X Slope (%)	N/A	Yes	DWS Full Width?	Yes
N/A	Landing Curb? (Y/N)	No	Yes	DWS Offset (in)	1.0
N/A	Shared Landing?	No			
Yes	Gutter Ponding?	No	Yes	Gutter Slope (%)	1.3
Yes	Gutter Lip Ht (in)	0.0	No	Gutter X Slope (%)	3.6
N/A	Painted X Walk1?	Yes	N/A	Painted X Walk2?	N/A

Possible Solutions:

**Remove & Replace Entire Ramp.  
Remove & Replace Gutter.**

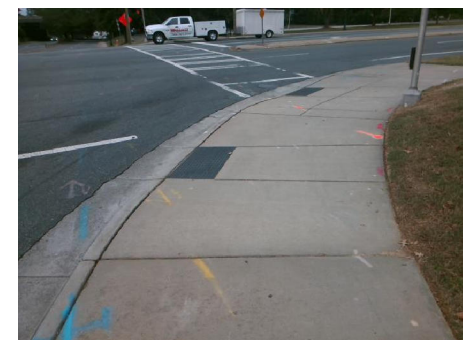
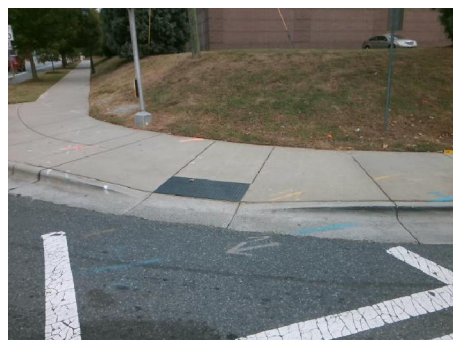
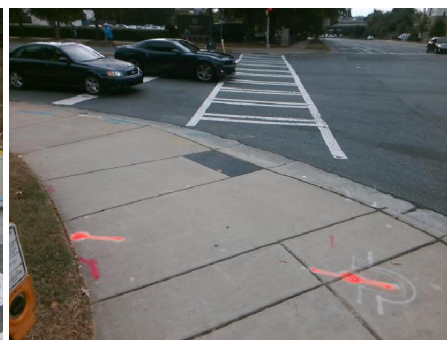
X Walk 1 Direction	To SE		X Walk 2 Direction	N/A
	X Walk 1 Width (in)	104.0		X Walk 2 Width (in)	N/A
	X Walk 1 Slope (%)	1.8		X Walk 2 Slope (%)	N/A
	X Walk 1 X Slope (%)	2.0		X Walk 2 X Slope (%)	N/A
Yes	Ramp inside XWalk1?	Yes	N/A	Ramp inside XWalk2?	N/A
	Road Slope (%)	N/A		Clear Space?	Yes
	Road X Slope (%)	N/A	N/A	Clear Space to XWalk (in)	N/A
			Yes	Any Obstruction?	No
				Obstruction Type	N/A
			Yes	Storm Grate/Utility Hazard?	No
				Storm Grate/Utility Type	N/A
			Yes	Surface Condition? (G/P)	Good
				Curb Slope (%)	9.0
