## **Access Compliance Report Public Rights-of-Way** (Curb Ramps)

Intersection ID: 10038774 Main Street: STEELE CREEK RD **Cross Street: N/A** Location: SE

ADA ID: F2BAE9CC75C1 Ramp Type: BlendTrans2 Initial Pass/Fail: Fail **Overall Compliance: No Severity Score:** 8.75

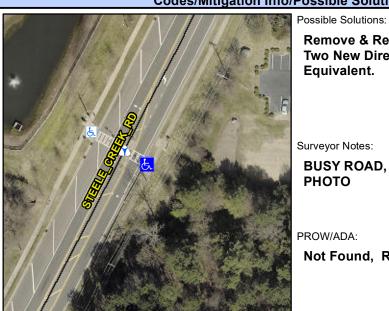
**BUSY ROAD, CANNOT GET FRONT PHOTO**

Field Measurements/Component Compliance					
Comp	liance Description	Data	Comp	liance Description	Data
N/A	Ramp Length (in)	107.0	Yes	BlendTrans Slope (%)	2.5
No	Ramp Width (in)	47.0	Yes	BlendTrans XSlope (%)	0.1
N/A	Flare Type LT	N/A	N/A	Flare Type RT	N/A
N/A	Flare Slope LT (%)	N/A	N/A	Flare Slope RT (%)	N/A
N/A	Flare Traversable LT?	N/A	N/A	Flare Traversable RT?	N/A
N/A	Landing Length (in)	N/A	N/A	DWS Provided?	N/A
N/A	Landing Width (in)	N/A	N/A	DWS Contrast?	N/A
N/A	Landing Slope (%)	N/A	N/A	DWS Length (in)	N/A
N/A	Landing X Slope (%)	N/A	N/A	DWS Full Width?	N/A
N/A	Landing Curb? (Y/N)	N/A	N/A	DWS Offset (in)	N/A
N/A	Shared Landing?	N/A			
N/A	Gutter Ponding?	N/A	N/A	Gutter Slope (%)	N/A
N/A	Gutter Lip Ht (in)	N/A	N/A	Gutter X Slope (%)	N/A
N/A	Painted X Walk1?	Yes	N/A	Painted X Walk2?	N/A
	X Walk 1 Direction	To NW		X Walk 2 Direction	N/A
	X Walk 1 Width (in)	108.0		X Walk 2 Width (in)	N/A
	X Walk 1 Slope (%)	9.2		X Walk 2 Slope (%)	N/A

X Walk 1 X Slope (%)	0.7		X Walk 2 X Slope (%)	N/A
N/A	Ramp inside XWalk1?	Yes	N/A	Ramp inside XWalk2?	N/A
	Road Slope (%)	0.7		Clear Space?	N/A
	Road X Slope (%)	9.2	N/A	Clear Space to XWalk (in)	N/A
N/A	Any Obstructions?	N/A	N/A	Storm Grate/Utility Hazard?	N/A
	Obstruction Type			Storm Grate/Utility Type	
		N/A			N/A
			Yes	Surface Condition? (G/P)	Good
			No	Curb Slope (%)	6.9

STEELE CREEK RD Street 1 Name Stop Condition-Street 1 Signal Street 2 Name N/A Stop Condition-Street 2 N/A **Remove & Replace Curb Ramp With** Two New Directional Ramps or Equivalent.
