## Access Compliance Report Public Rights-of-Way (Curb Ramps)

Intersection ID: 15882 Main Street: EAST\_BV Cross Street: QUEENS\_RD\_WEST Location: SE

ADA ID: F2BD5CB13DEF Ramp Type: Perp Initial Pass/Fail: Fail Overall Compliance: No Severity Score: 12.5

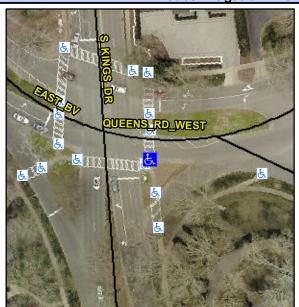
Field Measurements/Component Compliance							
Compliance Description		Data	Comp	oliance Description	Data		
N/A	Ramp Length (in)	89.5	Yes	Ramp Slope (%)	7.7		
Yes	Ramp Width (in)	59.0	No	Ramp XSlope (%)	6.8		
N/A	Flare Type LT	N/A	N/A	Flare Type RT	N/A		
N/A	Flare Slope LT (%)	N/A	N/A	Flare Slope RT (%)	N/A		
N/A	Flare Traversable LT?	N/A	N/A	Flare Traversable RT?	N/A		
N/A	Landing Length (in)	N/A	N/A	DWS Provided?	N/A		
N/A	Landing Width (in)	N/A	N/A	DWS Contrast?	N/A		
N/A	Landing Slope (%)	N/A	N/A	DWS Length (in)	N/A		
N/A	Landing X Slope (%)	N/A	N/A	DWS Full Width?	N/A		
N/A	Landing Curb? (Y/N)	N/A	N/A	DWS Offset (in)	N/A		
N/A	Shared Landing?	N/A					
N/A	Gutter Ponding?	N/A	N/A	Gutter Slope (%)	N/A		
N/A	Gutter Lip Ht (in)	N/A	N/A	Gutter X Slope (%)	N/A		
N/A	Painted X Walk1?	Yes	N/A	Painted X Walk2?	N/A		
	X Walk 1 Direction	To N		X Walk 2 Direction	N/A		
N/A	X Walk 1 Width (in)	106.0	N/A	X Walk 2 Width (in)	N/A

X Walk 1 Slope (%)	1.9		X Walk 2 Slope (%)	N/A		
	X Walk 1 X Slope (%)	1.8		X Walk 2 X Slope (%)	N/A		
N/A	Ramp inside XWalk1?	Yes	N/A	Ramp inside XWalk2?	N/A		
	Road Slope (%)	N/A	N/A	Clear Space?	N/A		
	Road X Slope (%)	N/A	N/A	Clear Space to XWalk (in)	N/A		
N/A	Any Obstructions?	N/A	N/A	Storm Grate/Utility Hazard?	N/A		
	Obstruction Type			Storm Grate/Utility Type			
		N/A			N/A		
			Yes	Surface Condition? (G/P)	Good		
	<b>東部門 育りを持</b>

1	Possible Solutions:				
X ****	Remove & Replace Entire Ramp.				
6	Surveyor Notes:				
2141	N/A				
Q.	PROW/ADA:				
The Control of the Co	R304.5.3
