# Access Compliance Report

## Public Rights-of-Way

### (Curb Ramps)

Intersection ID: 30253	Main Street: CENTENNIAL_DR	Cross Street: OLD_IRONSIDE_DR	Location: E
ADA ID: F2C0CE0254AD	Ramp Type: PerpDiag	Initial Pass/Fail: Fail	Overall Compliance: No
		Severity Score: 25

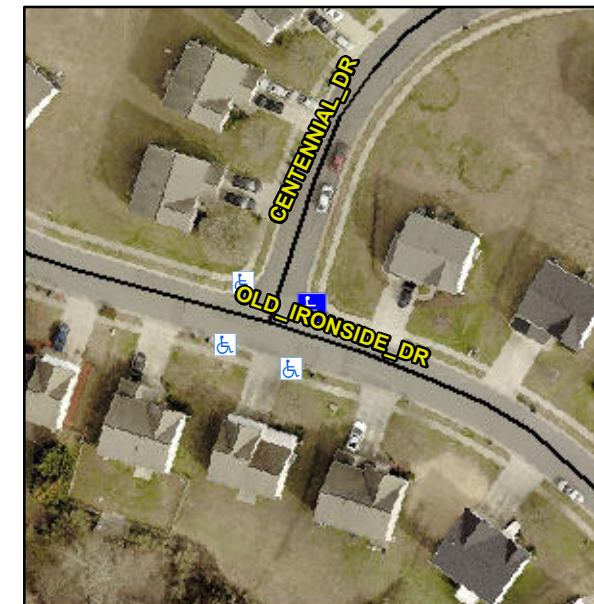
**Not Found, R304.2.2, R304.5.3**

Compliance	Description	Data	Compliance	Description	Data
N/A	Ramp Length (in)	46.0	No	Ramp Slope (%)	8.7
Yes	Ramp Width (in)	55.0	No	Ramp XSlope (%)	6.2
N/A	Flare Type LT	N/A	N/A	Flare Type RT	N/A
N/A	Flare Slope LT (%)	N/A	N/A	Flare Slope RT (%)	N/A
N/A	Flare Traversable LT?	N/A	N/A	Flare Traversable RT?	N/A
N/A	Landing Length (in)	N/A	N/A	DWS Provided?	N/A
N/A	Landing Width (in)	N/A	N/A	DWS Contrast?	N/A
N/A	Landing Slope (%)	N/A	N/A	DWS Length (in)	N/A
N/A	Landing X Slope (%)	N/A	N/A	DWS Full Width?	N/A
N/A	Landing Curb? (Y/N)	N/A	N/A	DWS Offset (in)	N/A
N/A	Shared Landing?	N/A			
N/A	Gutter Ponding?	N/A	N/A	Gutter Slope (%)	N/A
N/A	Gutter Lip Ht (in)	N/A	N/A	Gutter X Slope (%)	N/A
N/A	Painted X Walk1?	No	N/A	Painted X Walk2?	No
	X Walk 1 Direction	To NW		X Walk 2 Direction	To SW
N/A	X Walk 1 Width (in)	N/A	N/A	X Walk 2 Width (in)	N/A
	X Walk 1 Slope (%)	1.1		X Walk 2 Slope (%)	4.9
	X Walk 1 X Slope (%)	4.8		X Walk 2 X Slope (%)	0.5

N/A	Ramp inside XWalk1?	N/A	N/A	Ramp inside XWalk2?	N/A
	Road Slope (%)	4.0	N/A	Clear Space?	N/A
	Road X Slope (%)	5.8	N/A	Clear Space to XWalk (in)	N/A
N/A	Any Obstructions?	N/A	N/A	Storm Grate/Utility Hazard?	N/A
	Obstruction Type			Storm Grate/Utility Type	
		N/A			N/A
			Yes	Surface Condition? (G/P)	Good

**Remove & Replace Curb Ramp With Two New Directional Ramps or Equivalent.**

Total Cost: \$ 3200.00

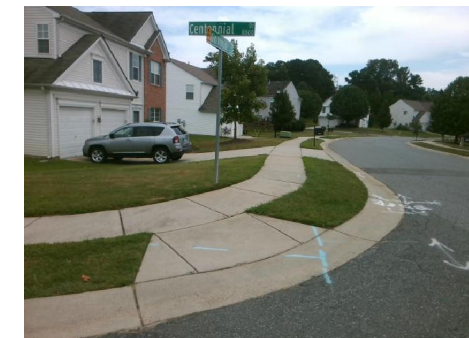
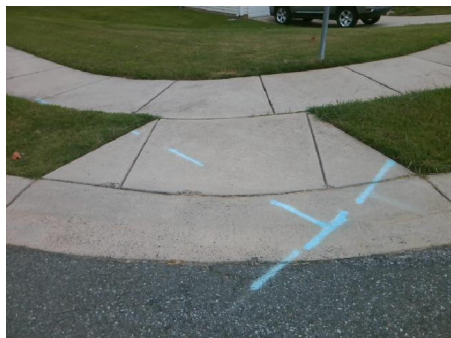
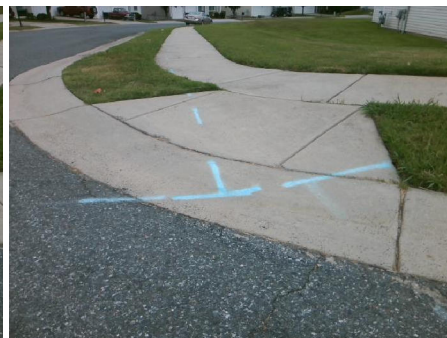
Street 1 Name **CENTENNIAL DR**  
 Stop Condition-Street 2 **StopSign**  
 Street 2 Name **OLD IRONSIDE DR**  
 Stop Condition-Street 1 **None**
