Access Compliance Report Public Rights-of-Way (Curb Ramps)

Intersection ID: 44452Main Street: BAYVIEW_PYCross Street: BUCKHORN_STLocation:SEADA ID: F2C4D21B89E1Ramp Type: PerpDiagInitial Pass/Fail: FailOverall Compliance: NoSeverity Score:17.5

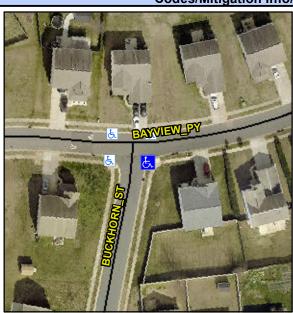
Field Measurements/Component Compliance									
	Compliance Description		Data	Compliance		Description	Data		
	N/A	Ramp Length (in)	49.5	Yes	Ramp	Slope (%)	7.0		
	No	Ramp Width (in)	35.0	Yes	Ramp	XSlope (%)	2.0		
	N/A	Flare Type LT	N/A	N/A	Flare	Type RT	N/A		
	N/A	Flare Slope LT (%)	N/A	N/A	Flare	Slope RT (%)	N/A		
	N/A	Flare Traversable LT?	N/A	N/A	Flare	Traversable RT?	N/A		
	N/A	Landing Length (in)	N/A	N/A	DWS	Provided?	N/A		
	N/A	Landing Width (in)	N/A	N/A	DWS	Contrast?	N/A		
	N/A	Landing Slope (%)	N/A	N/A	DWS	Length (in)	N/A		
	N/A	Landing X Slope (%)	N/A	N/A	DWS	Full Width?	N/A		
	N/A	Landing Curb? (Y/N)	N/A	N/A	DWS	Offset (in)	N/A		
	N/A	Shared Landing?	N/A						
	N/A	Gutter Ponding?	N/A	N/A	Gutte	r Slope (%)	N/A		
	N/A	Gutter Lip Ht (in)	N/A	N/A	Gutte	r X Slope (%)	N/A		
	N/A	Painted X Walk1?	No	N/A	Painte	ed X Walk2?	No		
		X Walk 1 Direction	To N		X Wal	lk 2 Direction	To W		
	N/A	X Walk 1 Width (in)	N/A	N/A	X Wal	lk 2 Width (in)	N/A

X Walk 1 Slope (%)	1.2		X Wal	lk 2 Slope (%)	3.7		
		X Walk 1 X Slope (%)	2.3		X Wal	lk 2 X Slope (%)	0.1		
	N/A	Ramp inside XWalk1?	N/A	N/A	Ramp	inside XWalk2?	N/A		
		Road Slope (%)	3.1	N/A	Clear	Space?	N/A		
		Road X Slope (%)	3.1	N/A	Clear	Space to XWalk (in)	N/A		
	N/A	Any Obstructions?	N/A	N/A	Storm	Grate/Utility Hazard?	N/A		
		Obstruction Type			Storm	Grate/Utility Type			
			N/A				N/A		
				Yes	Surfac	ce Condition? (G/P)	Good

- OSSIDIE SOIULION				
Possible Solutions:	Co			
Remove & Replace Curb Ramp With Two New Directional Ramps or				
	N/A			
	N/A			
	N/A			
Surveyor Notes:	N/A			
N/A	N/A			
	N/A			
	N/A			
	N/A			
PROW/ADA:	N/A			
Not Found, R304.5.1	N/A

Total Cost: \$ 3200.00
